CALIFORNIA'S LARGEST CARBON FIBER RETAINING WALL REPAIR PROJECT.

PALM SPRINGS, CA

Project Background:

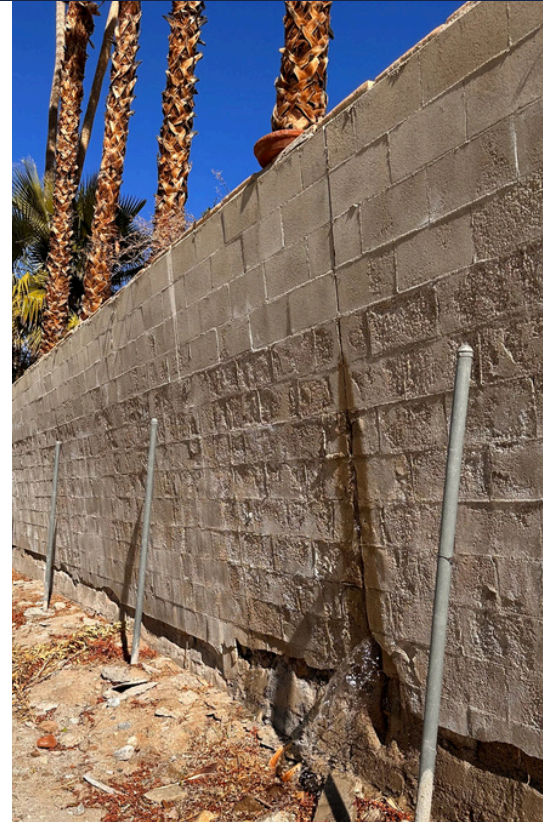
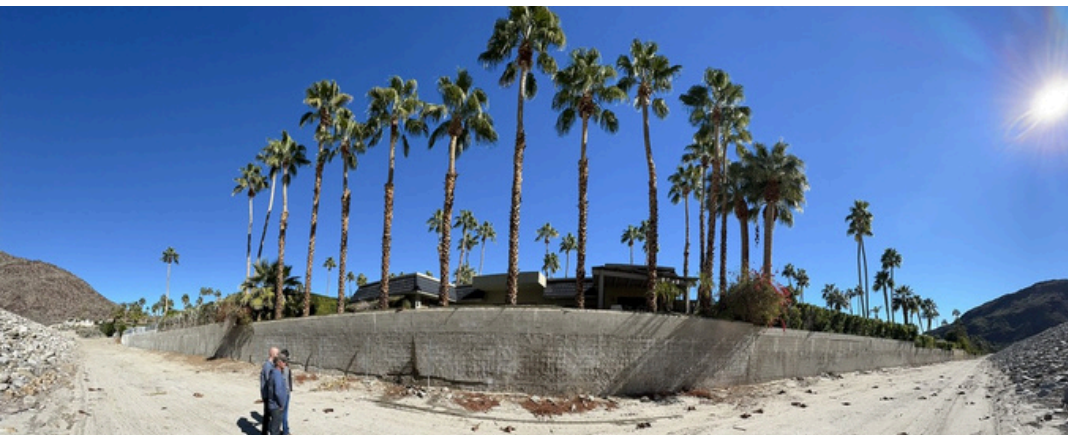
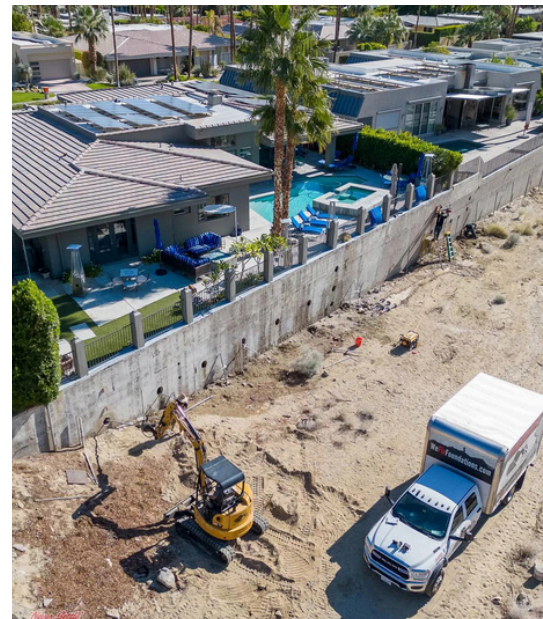
A 650 foot-long retaining wall supporting six luxury homes in Palm Springs, CA showed severe structural distress including tilting, cracking, and soil pressure-induced instability. Originally built in 1973, the wall had been affected by:

- Tree root pressure from large palm trees
- Added weight from pools, hot tubs, and irrigation systems
- Shifting soils and seismic activity in the region

- Structural Instability – The wall had significant cracking, tilting, and localized failures.
- Seismic Considerations – The high-risk seismic zone required additional considerations.
- Limited clearance for Tiebacks in certain areas – Pools prohibited tieback installation for large sections of the wall.

With limited space for invasive repairs, a collaborative effort between Helfrich Associates Engineering Consultants, Dalinghaus Construction, and Structural Reinforcement Solutions (SRS) led to a hybrid repair plan combining steel reinforcement and carbon fiber reinforced polymer (CFRP).

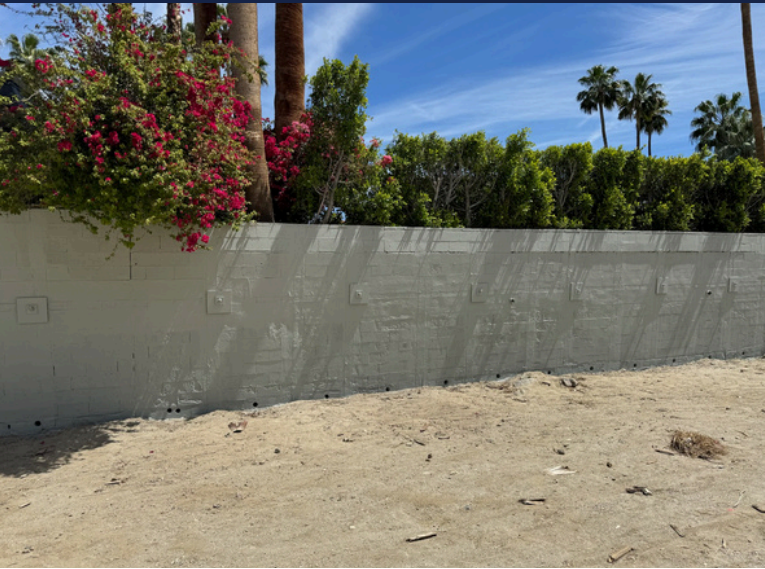
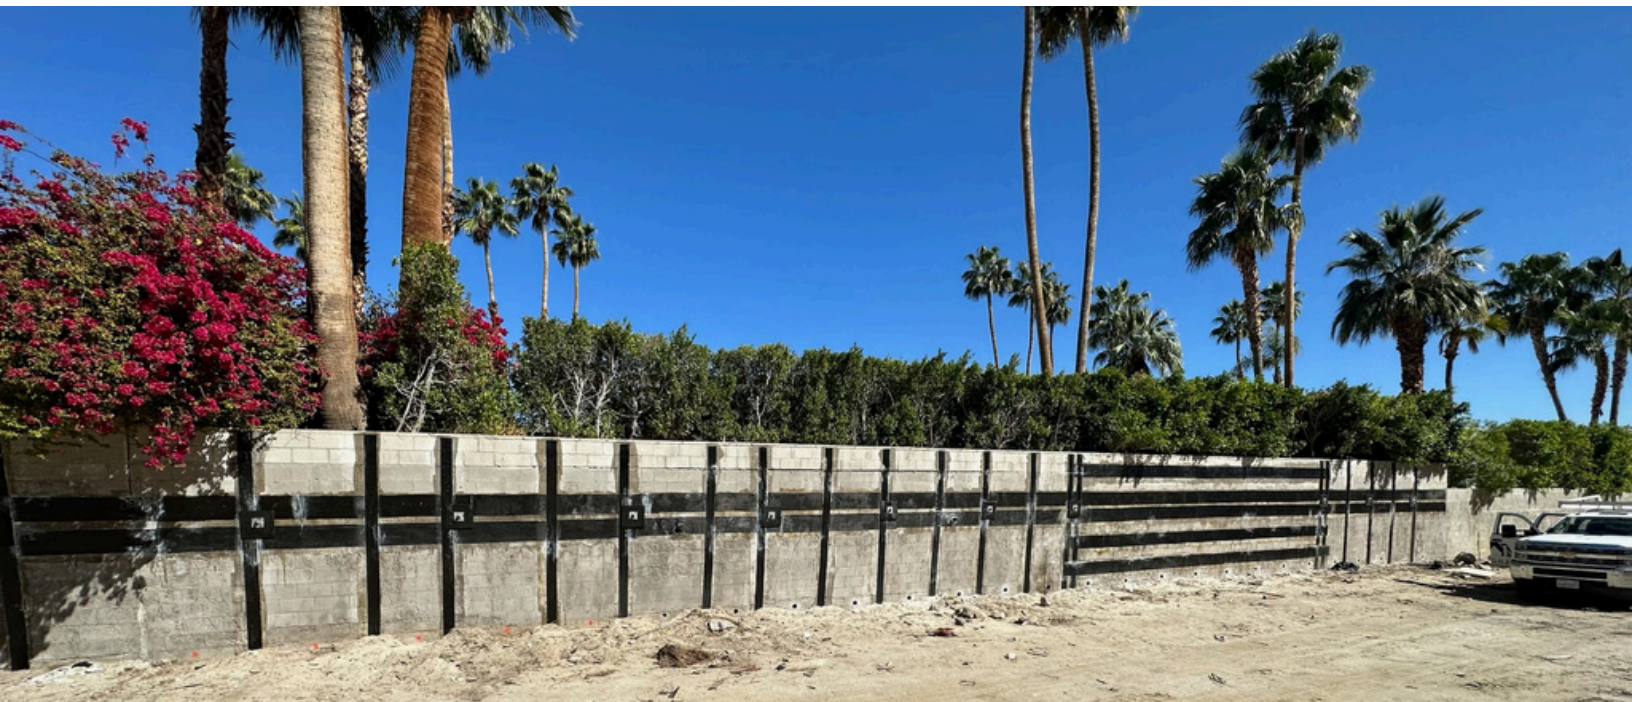
- Structural Integrity Restored – The wall was stabilized against soil pressure and seismic forces.
- Cost-Effective, Non-Invasive Repair – Avoided major excavation or full reconstruction.
- Increased Strength & Load Distribution – 6" wide SRS-600UNI provides over 2x the tensile strength of a #5 rebar.
- Preserved Aesthetics – The thin CFRP application when coated blends in to maintained the wall's appearance.
