# TIMBER PILE REHABILITATION USING CARBON FIBER REINFORCEMENT

PORTLAND, OR

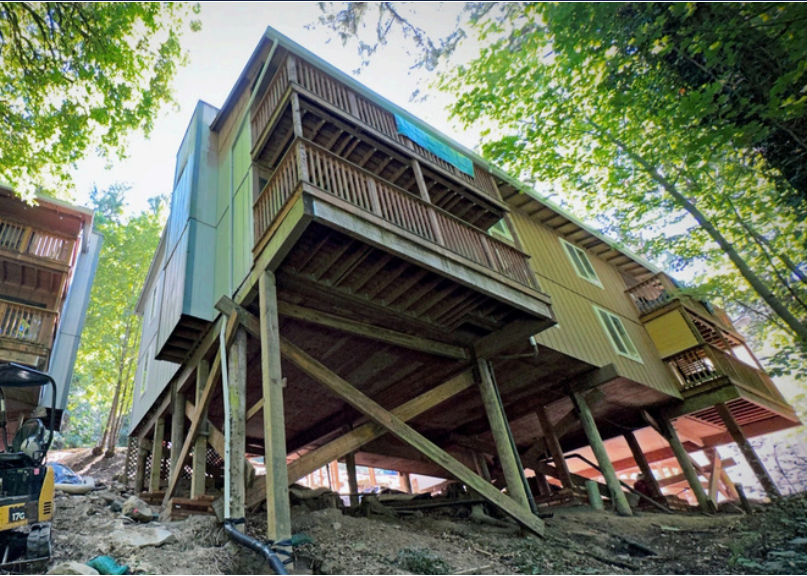
A residential complex comprised of six apartment buildings, was experiencing structural challenges due to deteriorating timber piles supporting the structures. The buildings, situated on a steep hillside, relied on these piles for foundational stability. Over time, environmental factors led to significant degradation of the timber, necessitating an effective and efficient rehabilitation solution.

- **Deterioration of Timber Piles:** The timber piles exhibited extensive rot and cross-sectional loss, compromising their load-bearing capacity.
- **Access Constraints:** The steep hillside location posed logistical challenges for conventional repair methods, requiring a minimally invasive approach.

After a thorough assessment, Carbon Fiber Reinforced Polymer (CFRP) was selected for the rehabilitation due to its high strength-to-weight ratio and adaptability in reinforcing timber structures. SRS developed a detailed repair plan utilizing CFRP to restore the piles' structural integrity while ensuring minimal disruption to the site.

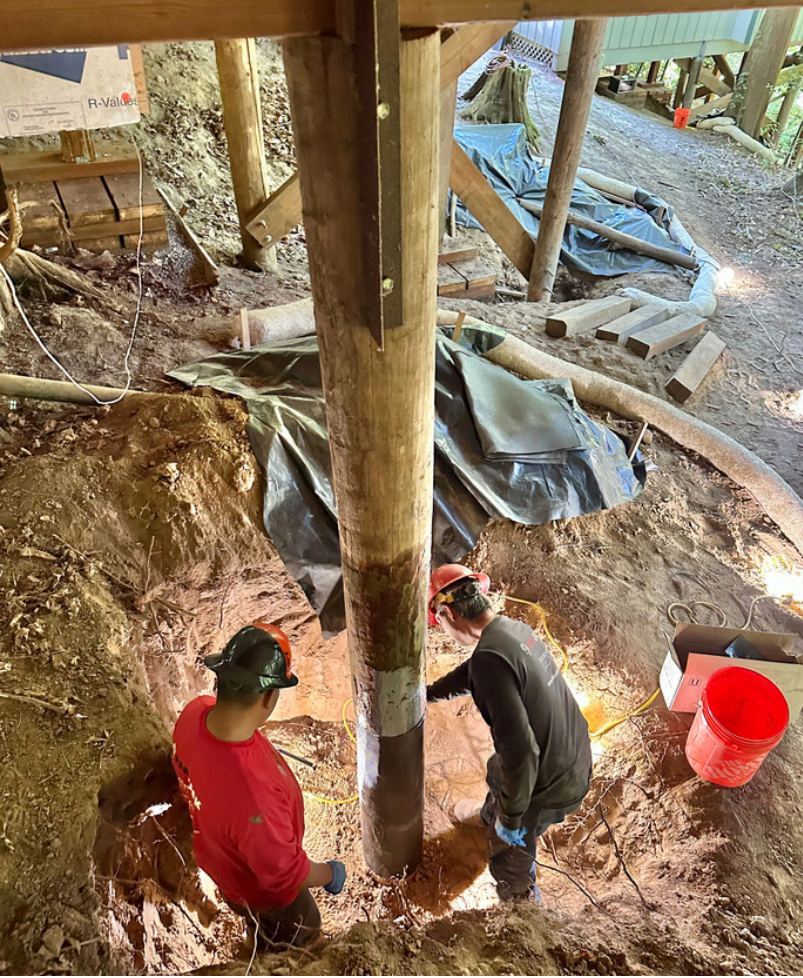
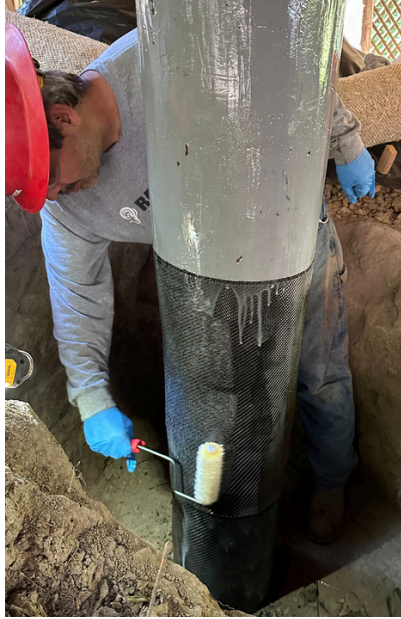
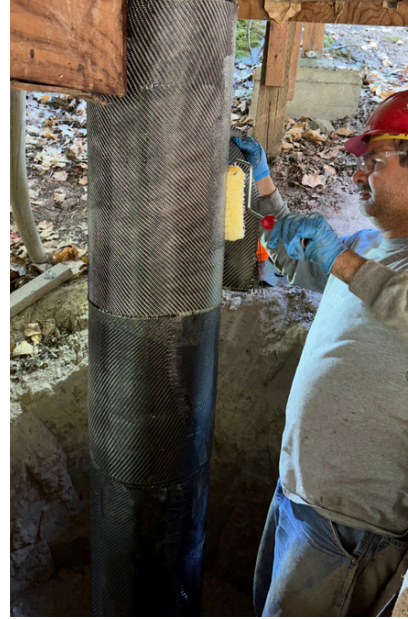
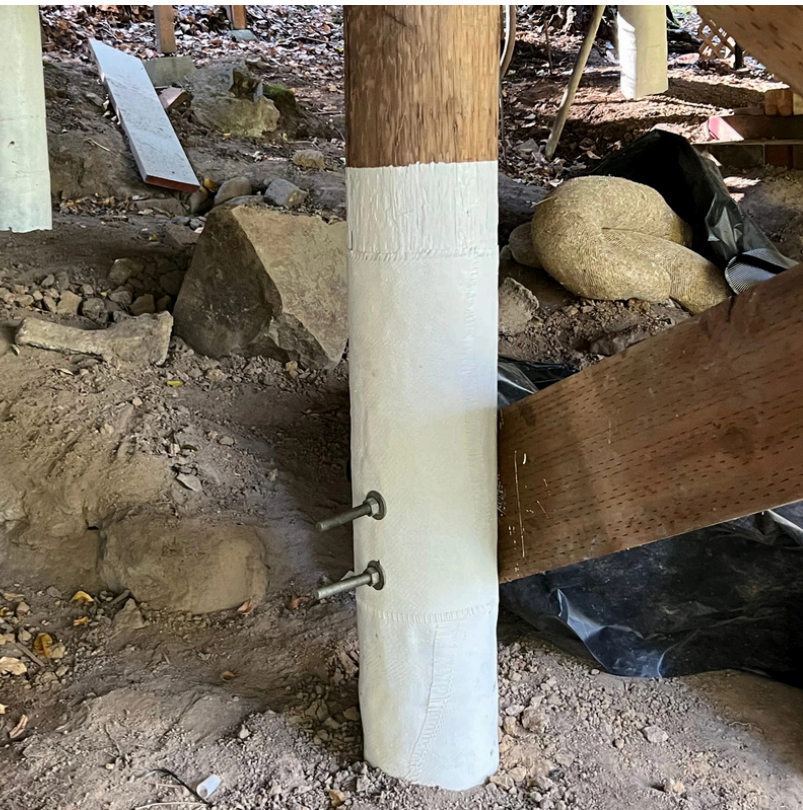
The CFRP reinforcement effectively restored the structural integrity of the timber piles, reinstating their load-bearing capacity and extending their service life. This minimally invasive method proved to be both practical and efficient, particularly given the site's challenging topography and environmental conditions.
