# CARBON FIBER REINFORCEMENT FOR POST-TENSIONED SLAB REPAIR

VERO BEACH, FL

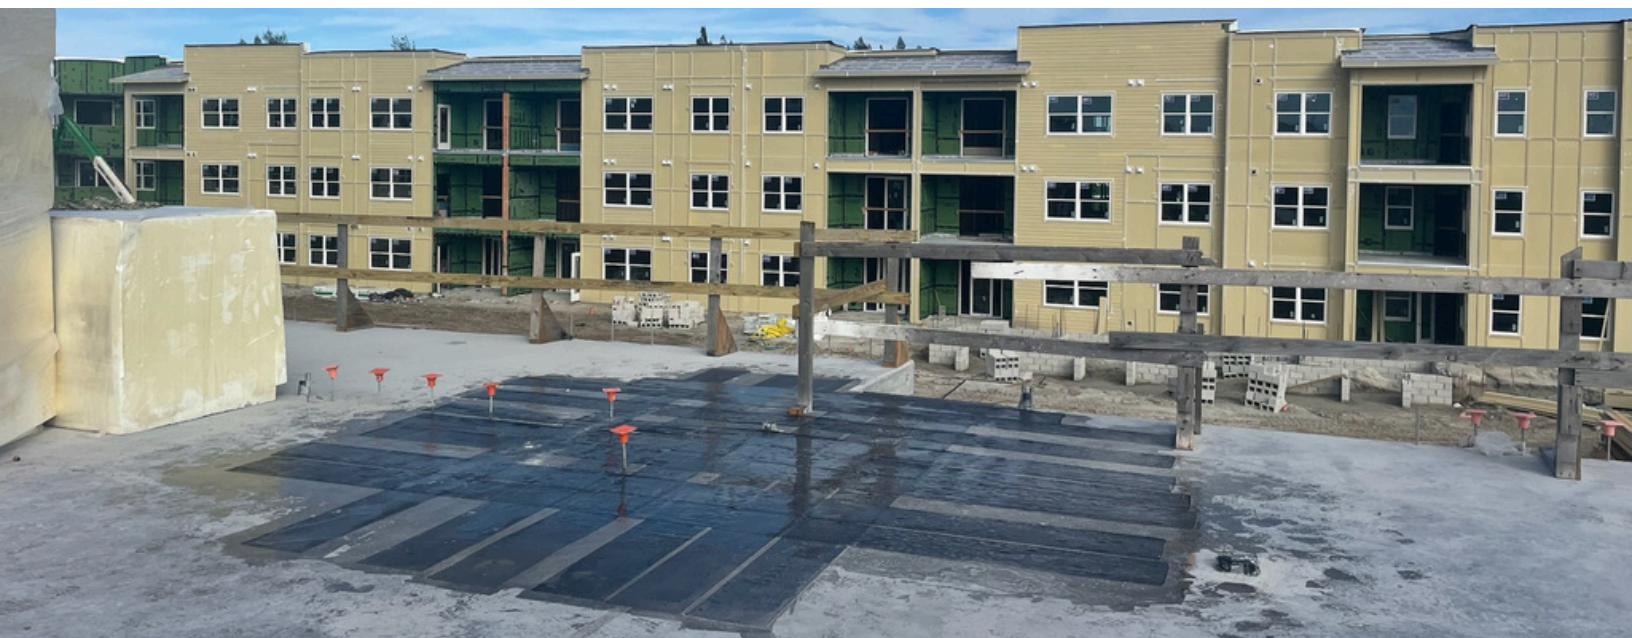
A large commercial structure required reinforcement for its post-tensioned (PT) concrete slab after construction errors resulted in excessive flexural stress at slab supports. Misaligned tendons caused a punching shear issue, compromising the slab's structural integrity. Initial repair considerations included drop panels to improve load distribution, but further strengthening was necessary to ensure long-term stability and safety.

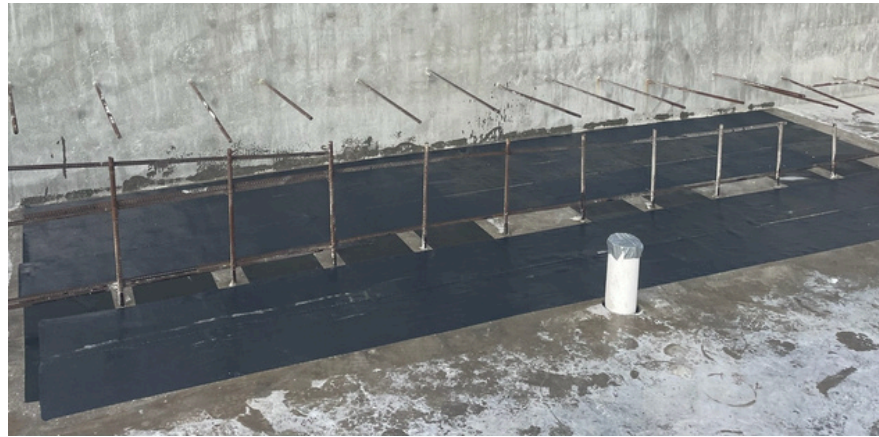
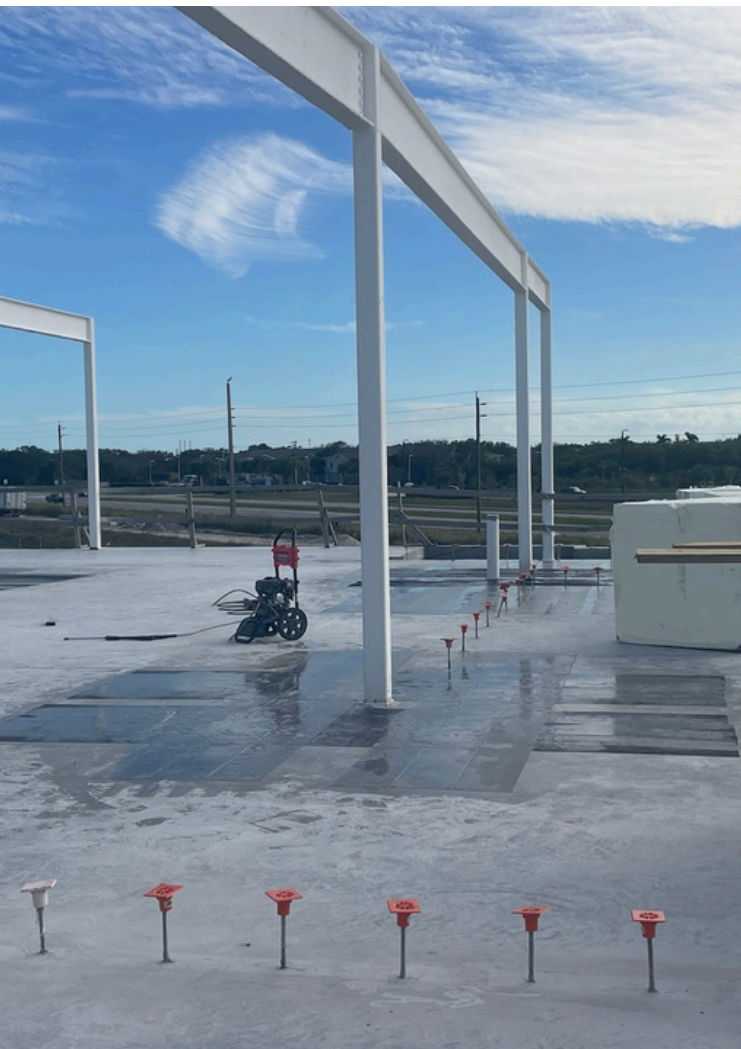
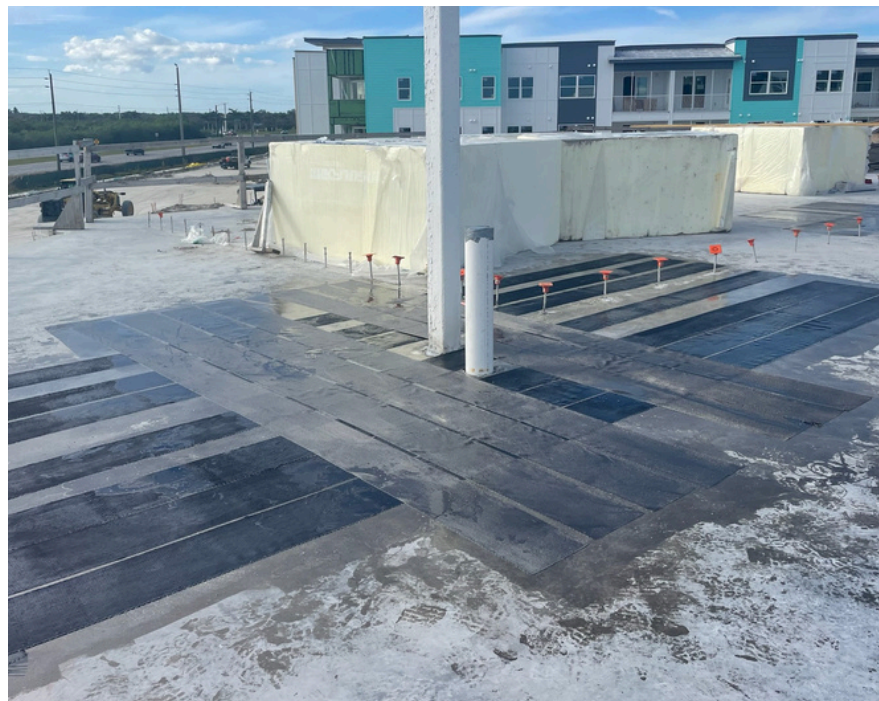
- **Surface Preparation:** The concrete surface was prepared to ensure optimal adhesion for the CFRP application.
- **Primary CFRP Strengthening:** The SRS-600 Unidirectional Carbon Fiber System was applied in high-stress areas to improve flexural capacity.

- **Shear Reinforcement:** In select locations requiring additional shear strengthening, SRS-660 BI-Directional Carbon Fiber Wraps were applied to enhance load transfer and confinement strength.
- **Load Transfer Considerations:** CFRP strips extended 18 inches beyond rebar locations to ensure proper anchoring and reinforcement effectiveness.

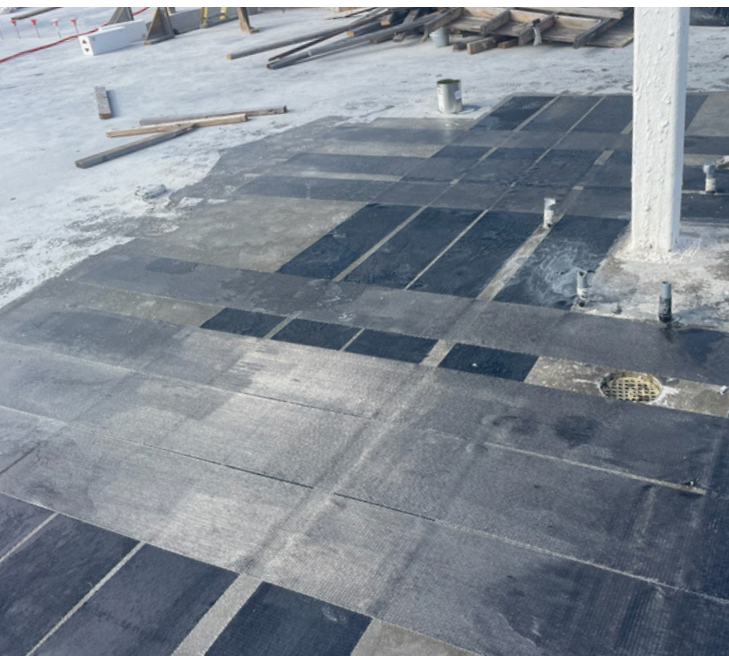
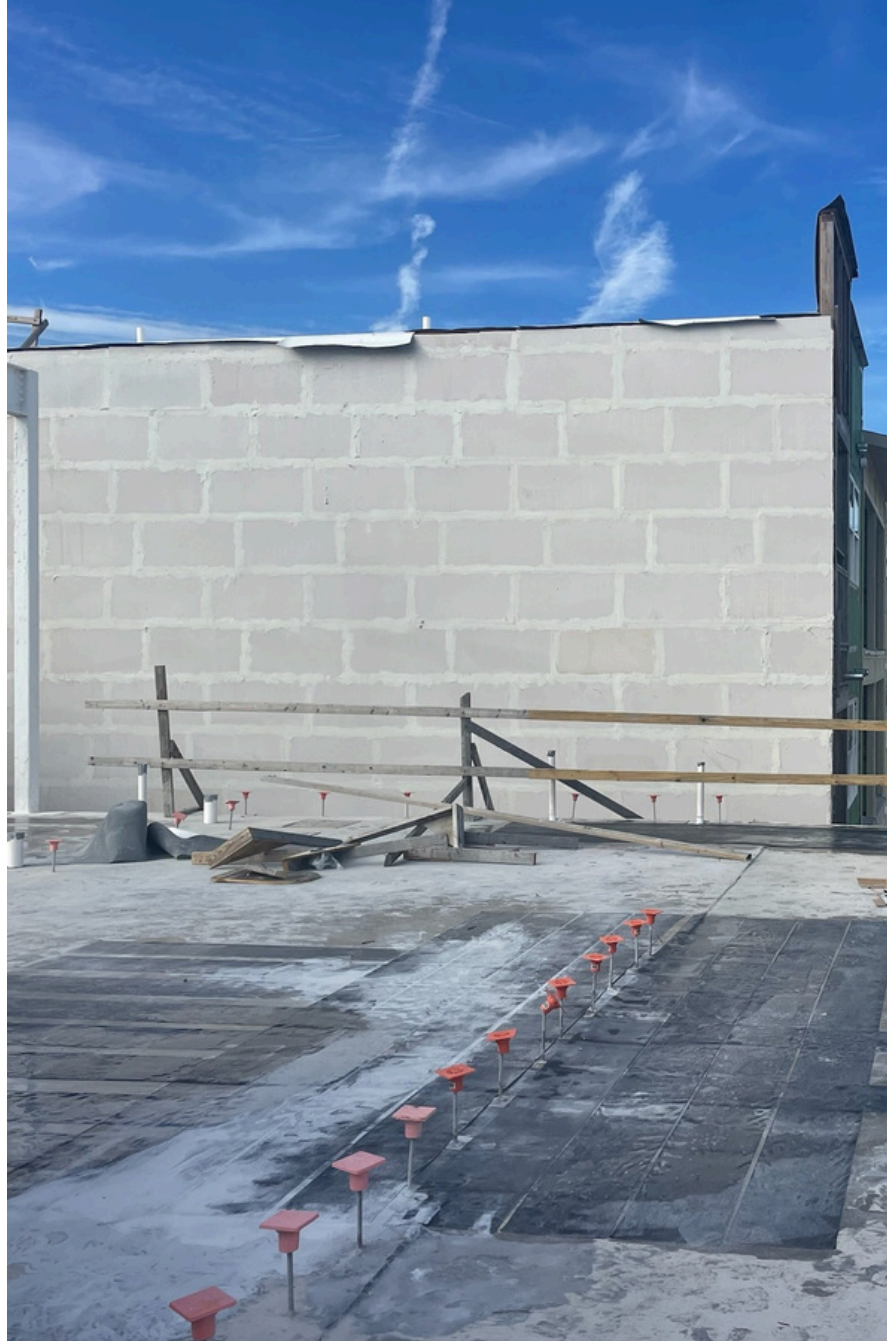
- The CFRP reinforcement system successfully restored the slab's structural integrity while avoiding costly and time-consuming demolition.
- Increased load-bearing capacity, addressing both flexural deficiencies and shear concerns.
- Significant cost savings compared to traditional concrete repair methods.
- Minimal facility downtime due to rapid installation.
- Long-term durability with CFRP providing a permanent strengthening solution.
