# RETAINING WALL REINFORCEMENT WITH CARBON FIBER

WOODLAND HILLS, CA

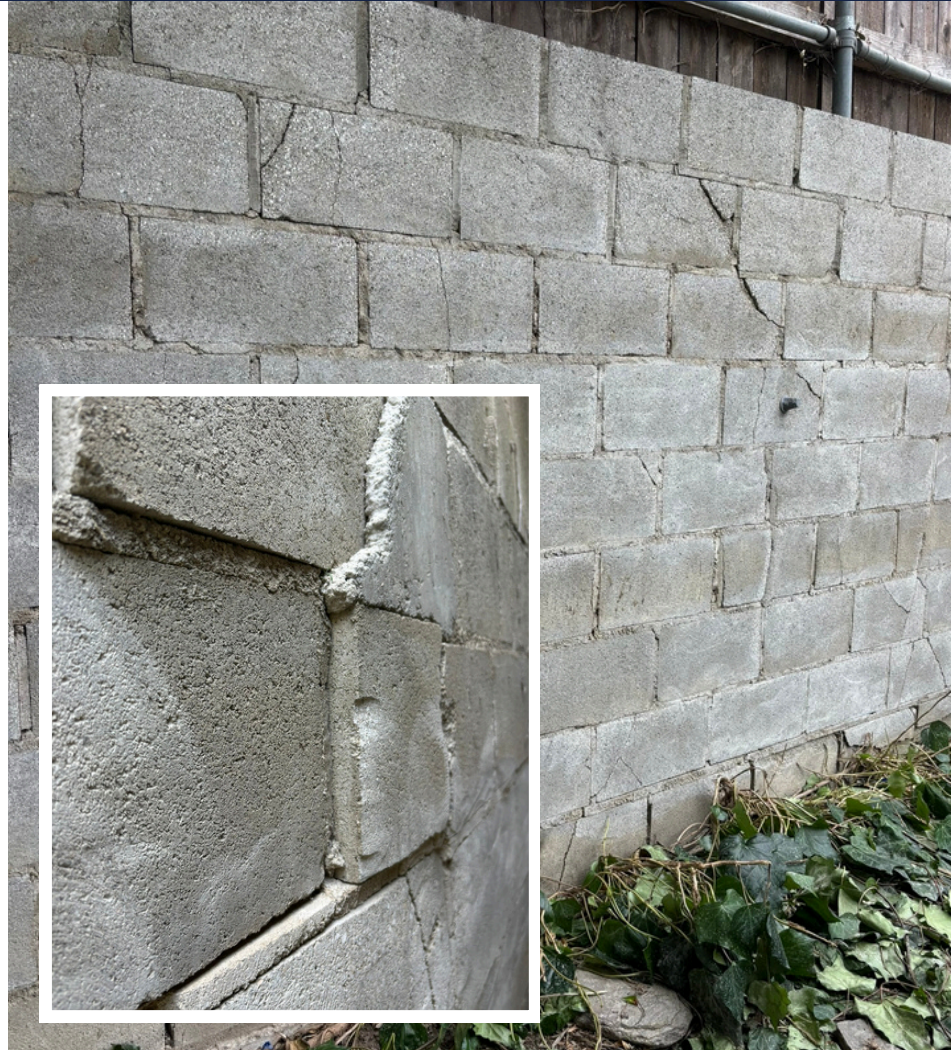
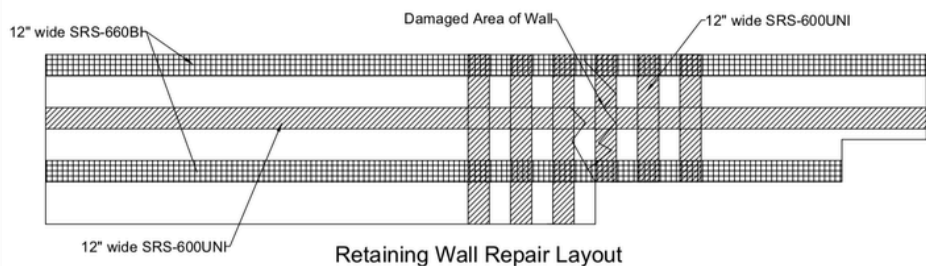
## The final layout included:

- Vertical 12" SRS-600UNI unidirectional straps for vertical and horizontal strength
- A central 12" SRS-600UNI horizontal strap for added support
- 12" SRS-660BI bidirectional straps at the top, bottom, and ends for anchorage and lateral reinforcement

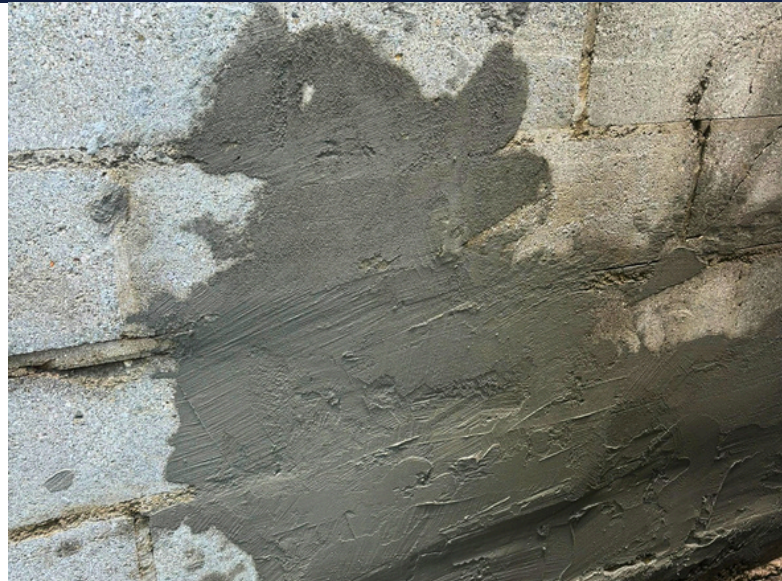
Before CFRP installation, all cracks were sealed with a non-compressible material and the wall surface was ground and leveled for optimal adhesion. Once the CFRP system was installed and the final layer of epoxy applied, sand was broadcast onto the surface to create a mechanical bond for the aesthetic coating to follow. This step helps ensure long-term durability and a clean, uniform finish.

Additional 12" SRS-660BI straps were used at the contractor's discretion for localized crack repairs. To stabilize the compromised section of wall, a new footing was poured beneath the affected area.

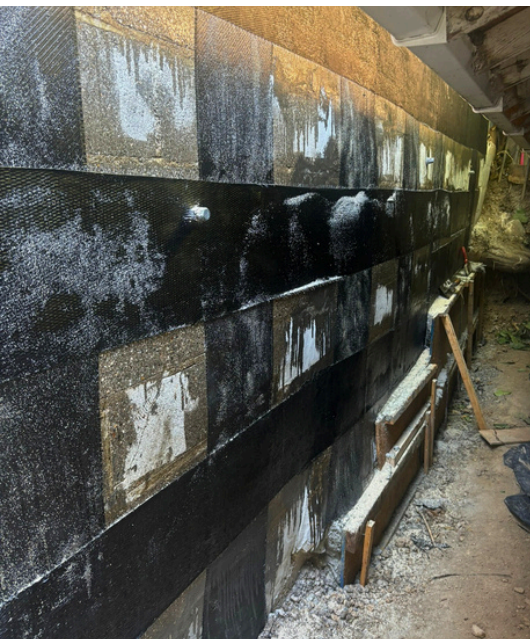
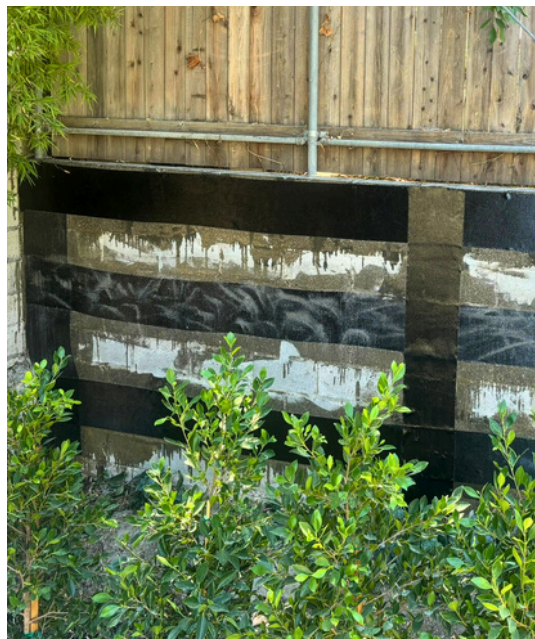
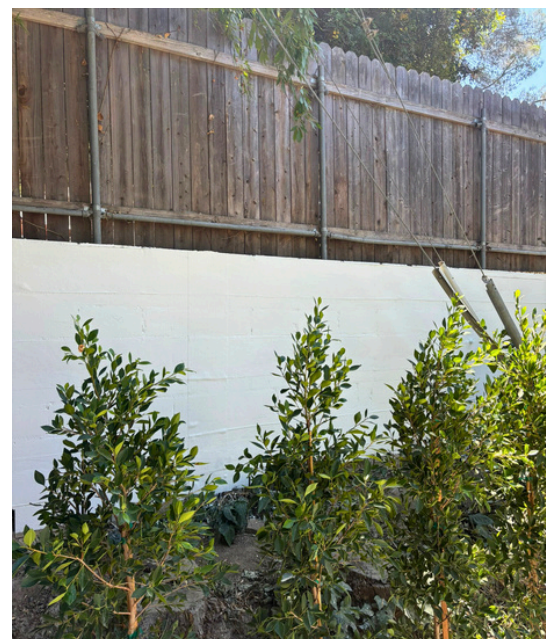
The hybrid system provided strength where it was needed most—without the need for full structural replacement. This high-performance carbon fiber solution delivered efficient reinforcement and long-term durability for the property owner.
