CARBON FIBER HURRICANE DAMAGE STRENGTHENING

OUTER BANKS, NORTH CAROLINA

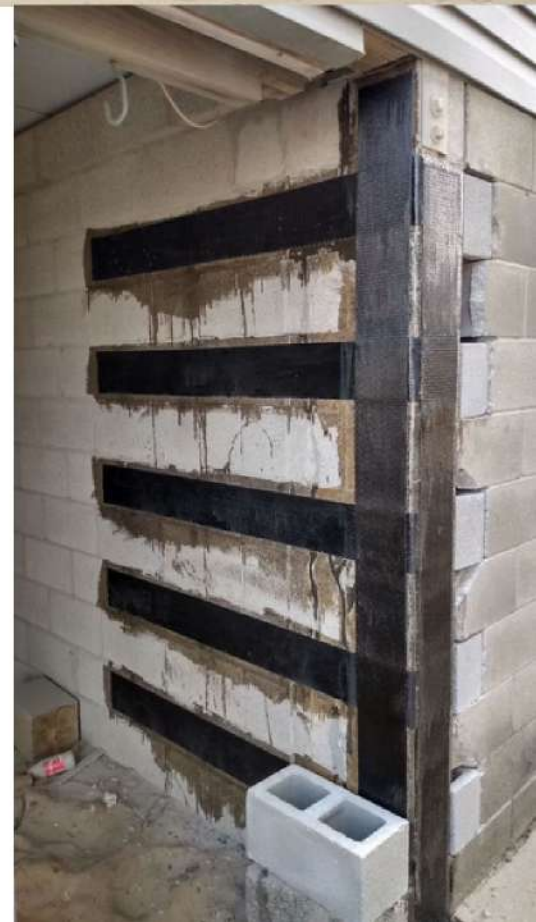
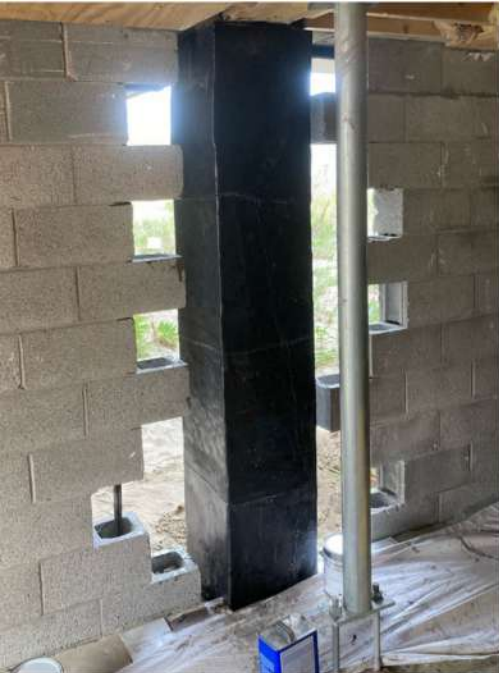
The damaged areas of the concrete structure were prepared by removing loose or deteriorated concrete, cleaning the surfaces, and roughening the substrate to achieve a suitable bond with the CFRP materials. Any corrosion on the reinforcement was treated and repaired.

The carbon fiber strengthening system, consisting of CFRP fabric impregnated with epoxy resin, was applied to the prepared concrete surfaces and bond beams. The CFRP material was strategically placed along the weakened structural elements, such as bond beams, columns, and walls, to provide additional flexural and shear strength.

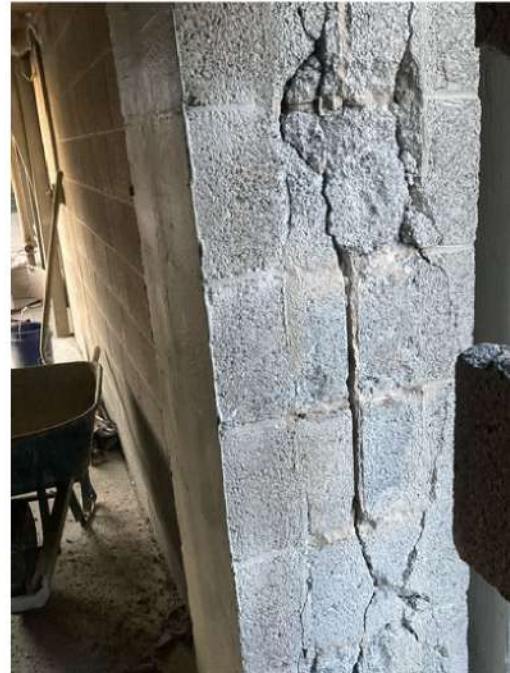
3 WALL REPAIR- NO BOND BEAM (TYP)
S8 SECTION VIEW: NTS

INSTALLATION OF 12" WIDE SRS-660BI STRAP
ENTIRE LENGTH OF WALL (CONTINUOUS)
BOTH SIDES PLACED DIRECTLY ON MASONRY

SON STRONG SS HM9 HURRICANE TIE @ 16" O.C.
SECTION THRU CFRP SHALL BE IN ACCORDANCE
MANUFACTURER SPECIFICATIONS.

SEE CRACK REPAIR DETAIL (AS
APPLICABLE)

REMOVE AND RESET FLASHING AS
REQUIRED

EAST FOUNDATION WALL VERIFIED BY GPR
TO BE GROUTED SOLID

SIMPSON STRONG STAINLESS STEEL TITEN HD HEAVY
DUTY SCREW ANCHOR INSTALLED @ 16" O.C.
