TILT-UP PRECAST CONCRETE PANEL STRENGTHENING

PUEBLO, COLORADO

CARBON FIBER STRENGTHENING SYSTEMS

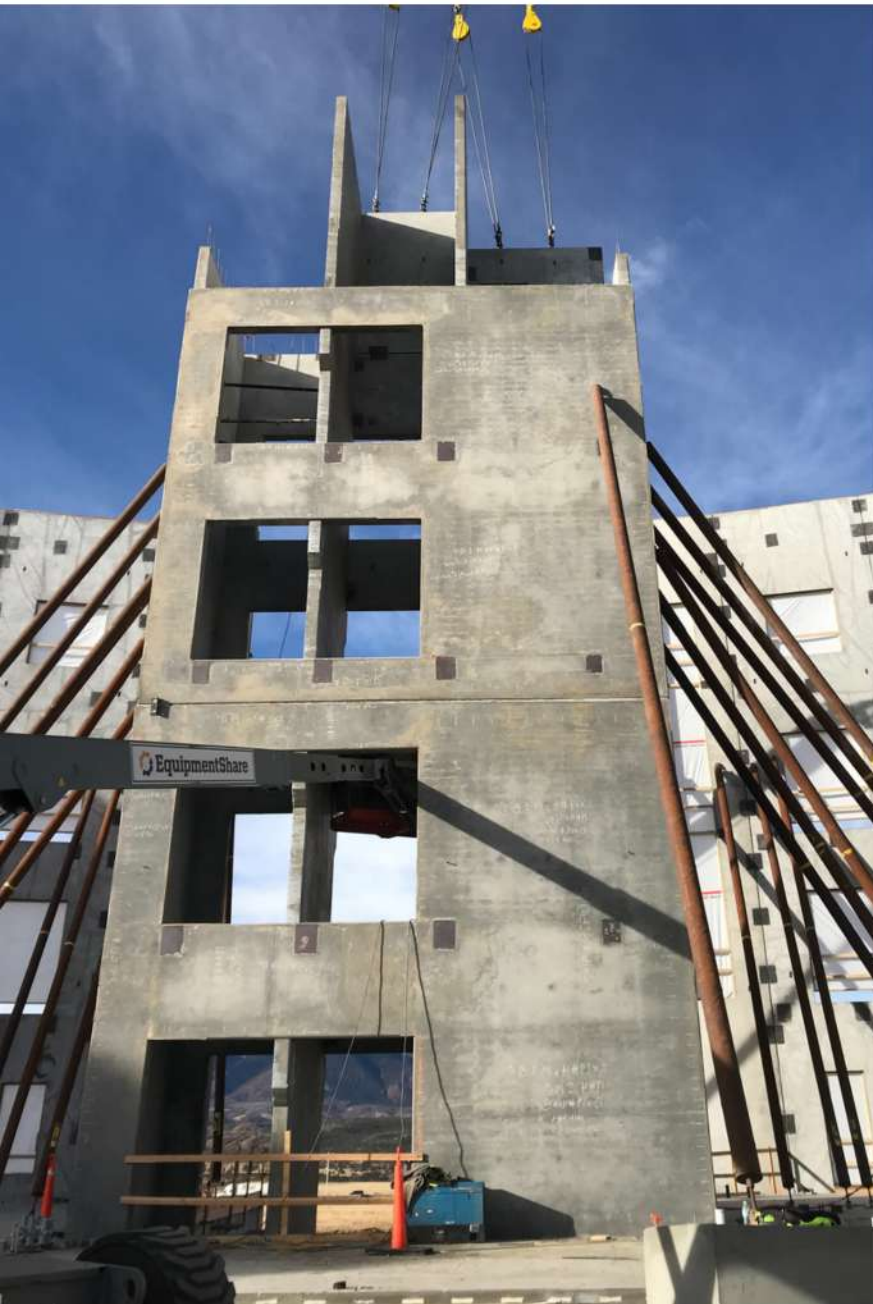
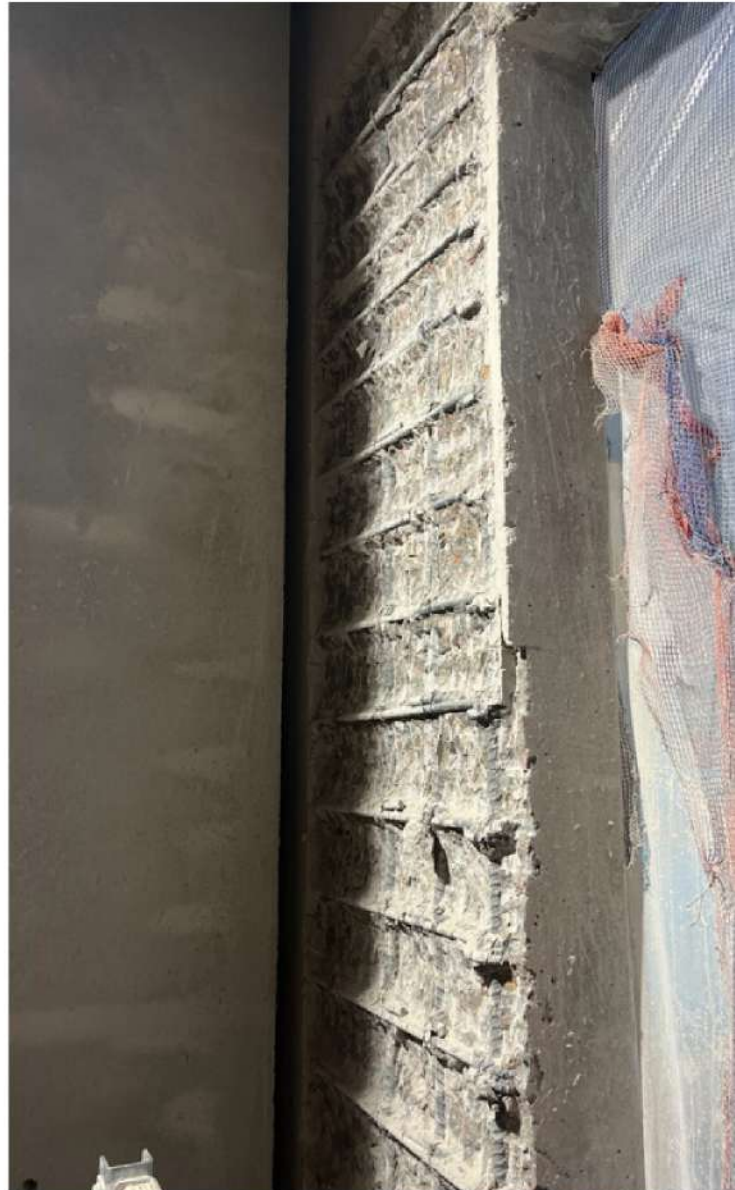
On a recent new construction project in Colorado Springs, Colorado there was a clearance issue between the elevator shaft equipment and one of the tilt up panels that made up the shaft. By the time the conflict was noticed, the panels had been set and adjusting them was no longer an option.

Due to the clearance issue, the concrete cover and the entire leg of the #4 bands on the inside face of the panel had to be removed to provide enough clearance to allow the installation of the elevator equipment. The rebar that had to be removed was along the edge of the panel, adjacent to the elevator door openings.

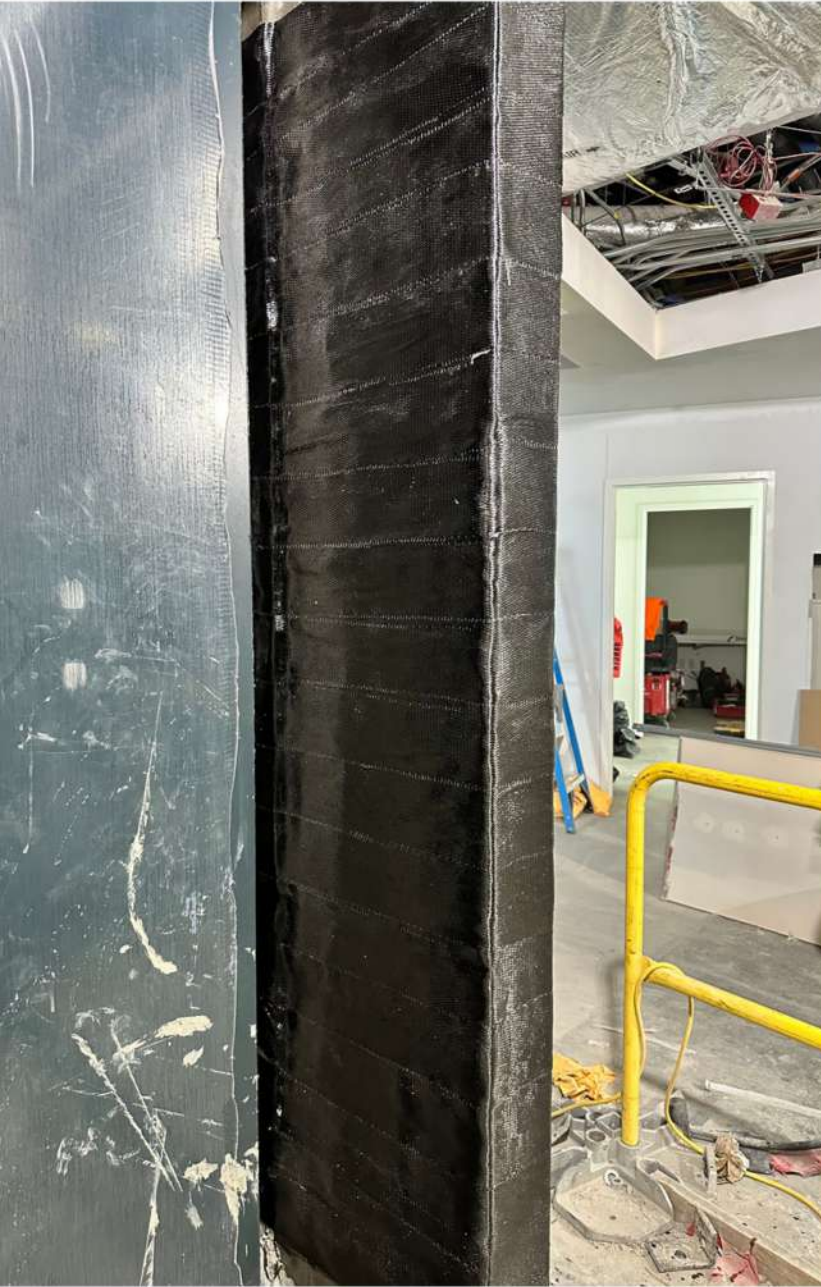
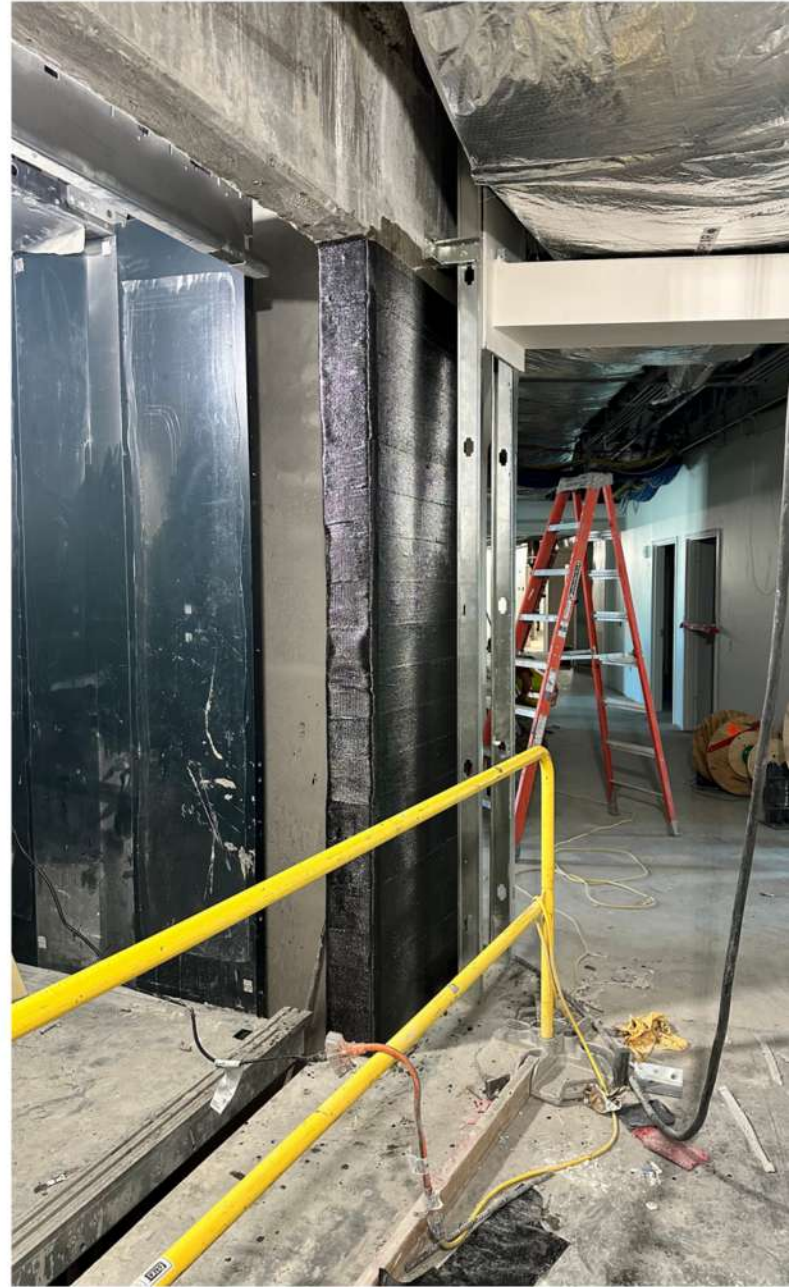
The remaining sections of the panel were essentially treated like columns and wrapped horizontally with SRS-600UNI in order to make up for the lost confinement strength after the removal of the horizontal bands. SRS-660BI was utilized to provide crack control and improve the lap lengths with the main section of the panel.
