# CARBON FIBER SEA WALL STRENGTHENING

CAMANO ISLAND, WASHINGTON STATE

## An unconventional and collaborative approach to strengthening Sea Walls in the Pacific North West.

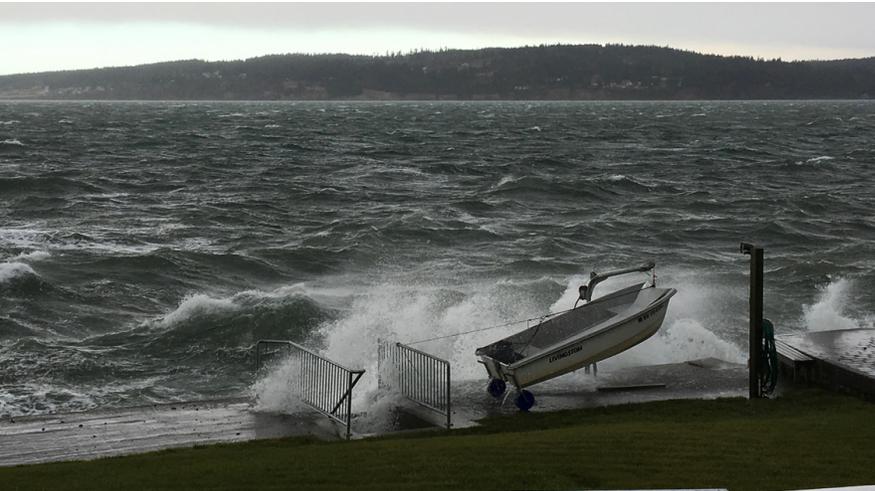
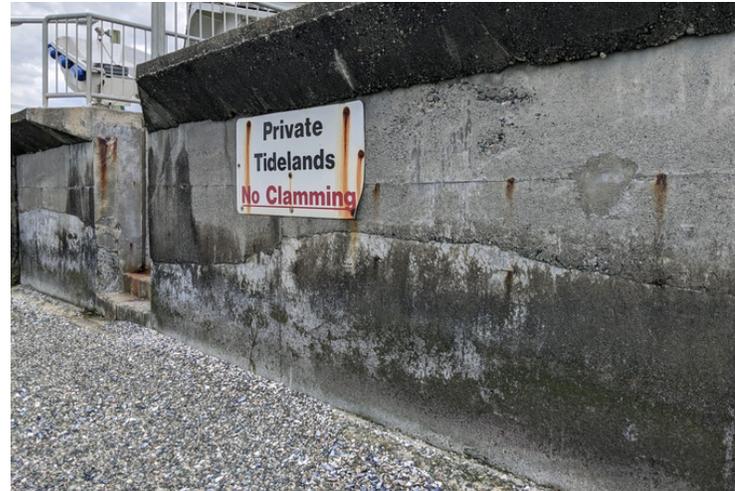
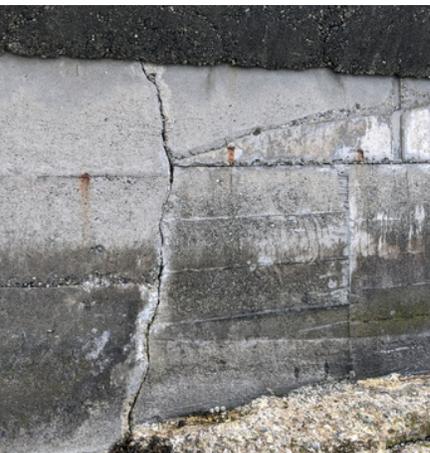
After years of wear and tear from rising and falling tides, debris, and rough seas, the owners of this oceanfront property in the San Juan Islands reached out to R&R Foundation Specialist for options to strengthen and preserve their seawall. The initial inspection revealed multiple cracks, joints, and areas of deterioration that needed to be addressed..

R&R reached out to SRS for support in putting together a reinforcement plan for the wall. A few of the neighboring properties had seawalls where cracks were addressed with CFRP but these were merely crack repair jobs. In this case, the owners wanted to strengthen the wall and preserve it for many years to come. Since the tides in this area of Camano Island vary greatly depending on the time of year, the installation was scheduled during a window that allowed the entire wall to be media blasted prior to the CFRP installation the following day.

Using an environmentally safe crushed glass medium, the entire surface of the wall was thoroughly prepared. This process removed years of algae and marine contaminants from the concrete substrate while opening up the pores of the concrete to allow for epoxy penetration

In this case, all of the cracks and deteriorated joints were addressed with the SRS-660BI in order to reestablish strength across the cracks as well as keep unwanted moisture from infiltrating the wall through these joints. The SRS-600UNI was used to provide global strengthening of the wall in order to make up for any section loss in the existing reinforcing steel and to provide additional reinforcement against the pressures from the soil behind the wall. The corners were also strengthened by wrapping them with the SRS-600UNI.

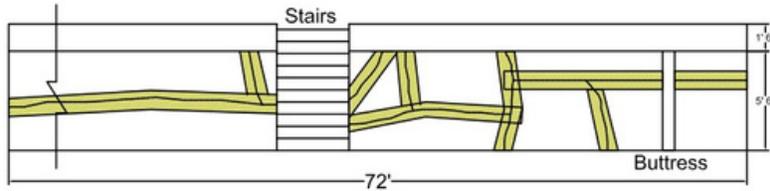
Crack Repairs - 12" Wide SRS-660BI

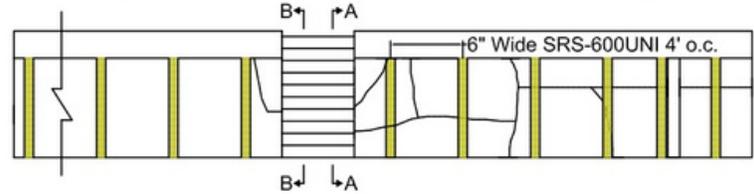
Supplemental Wall Reinforcement - 6" Wide SRS-600UNI

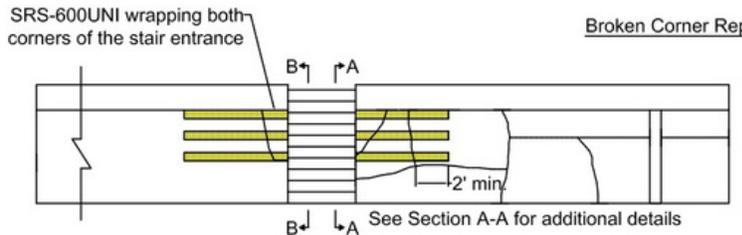
Broken Corner Repairs:

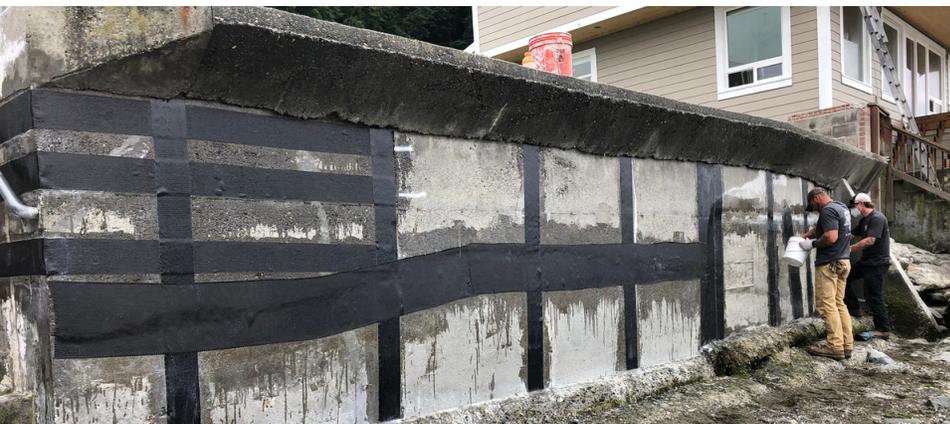
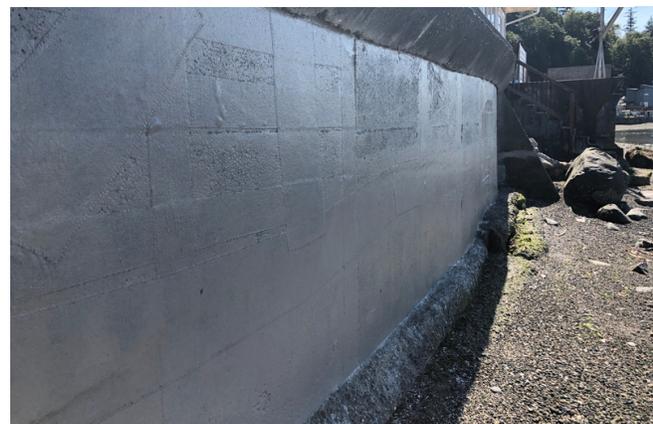
To address the environmental factors, a hybrid Epoxy/Kevlar marine coating was applied to the entire sea wall, providing a uniform finish while protecting the CFRP installation. This is just one example of the innovative repair solutions SRS has developed for the preservation of sea walls and concrete infrastructure.
