RETAINING WALL REPAIR & STRENGTHENING WITH CARBON FIBER

CALIFORNIA, USA

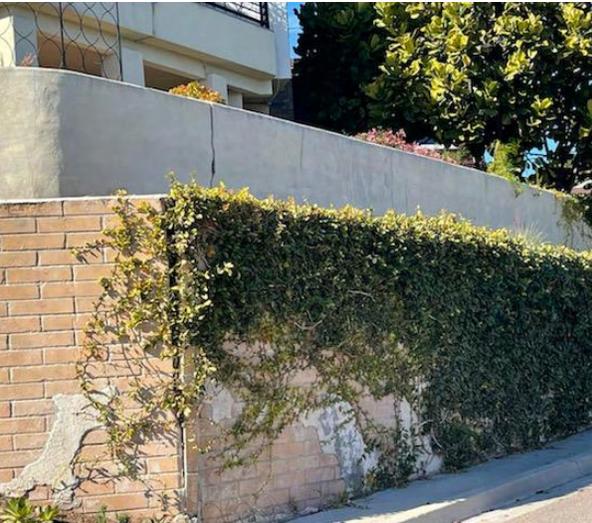
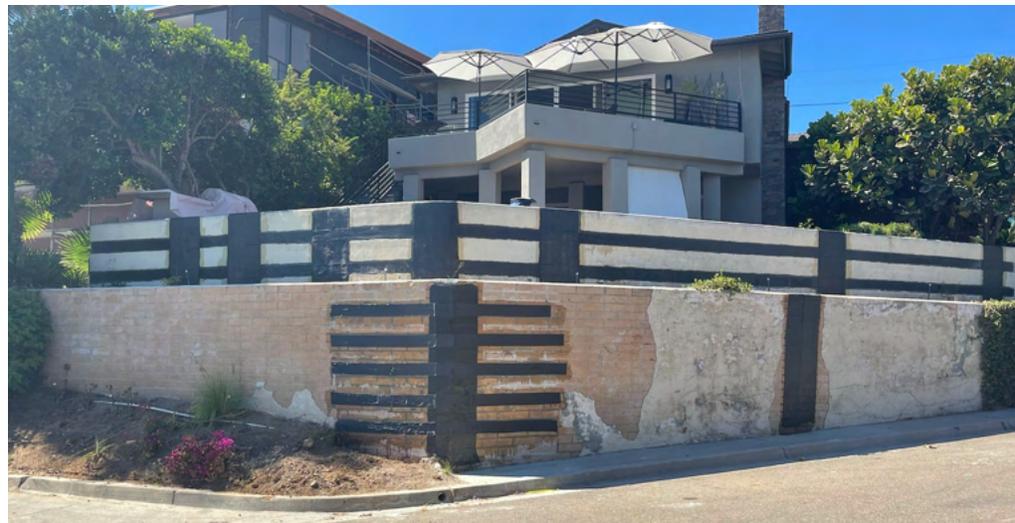
This two tier California retaining wall was no exception, as multiple vertical cracks developed in both the concrete and brick levels of the structure. The property owner contacted a foundation repair contractor who had past experience with carbon fiber structural repair. The contractor reached out to Structural Reinforcement Solutions (SRS) for a complete strengthening design that permanently addressed the walls structural issues.

By utilizing both SRS's unidirectional and bidirectional fabrics which are bonded to the substrate with a structural epoxy adhesive, the walls were able to be repaired and reinforced against future damage. The carbon fiber reinforced polymer system (CFRP) provided permanent localized crack reinforcement as well as global strengthening of the walls. The dual component American made system has been designed by engineers and rigorously tested to perform as a long lasting repair solution for these applications.

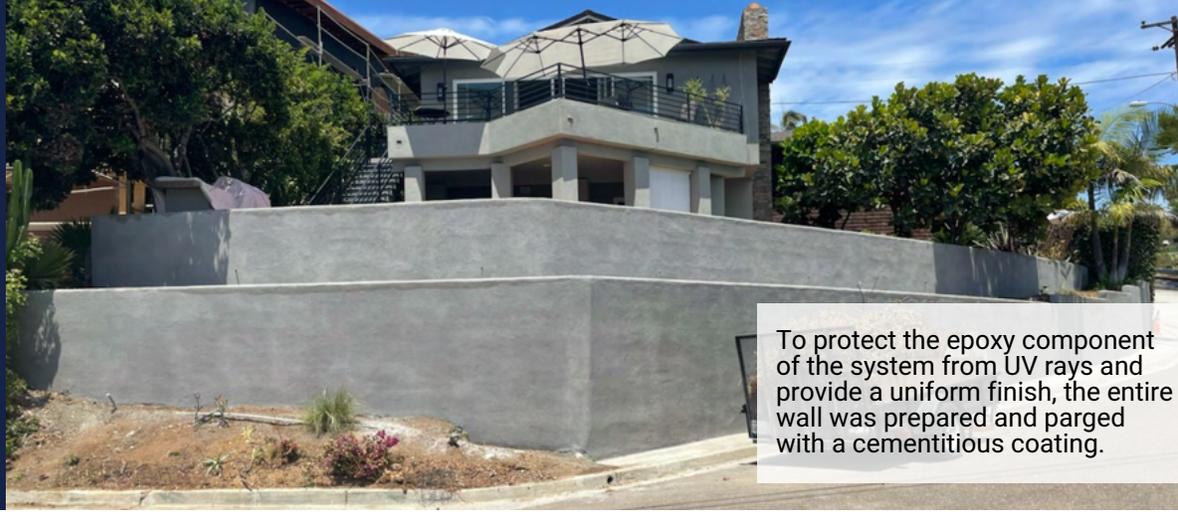
To protect the epoxy component of the system from UV rays and provide a uniform finish, the entire wall was prepared and parged with a cementitious coating.

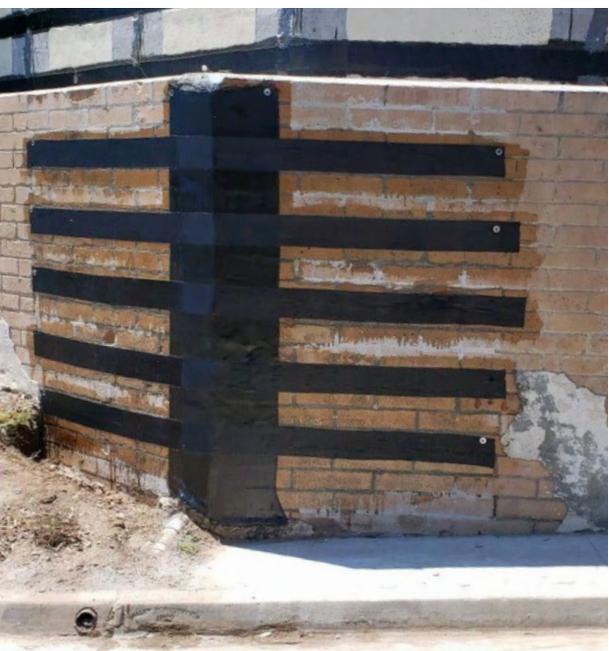
The surface of the bricks were prepared and cleaned prior to bonding the 24" SRS-660 bidirectional carbon fiber as a localized crack repair.

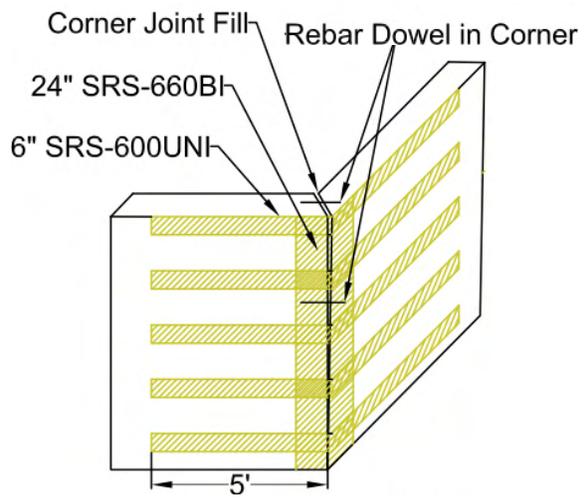
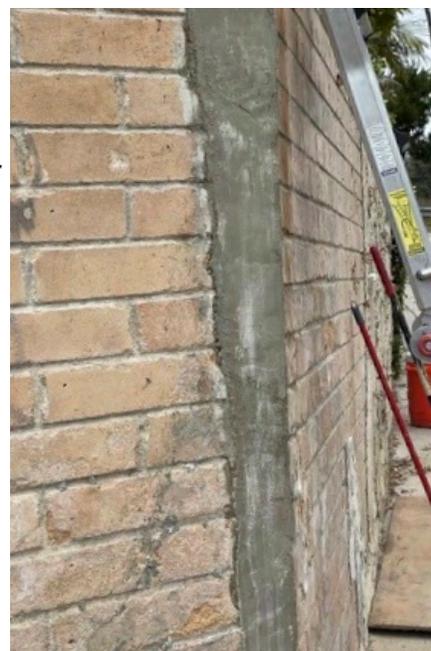
The large void in the broken corner joint was filled with a non-compressible hydraulic cement prior to the installation of the CFRP. To ensure a flat and even profile was met beneath the carbon fiber, each mortar joint was filled flush to allow for the SRS-600 Unidirectional carbon fiber to be securely wrapped around each side to provide global strengthening of the corner.

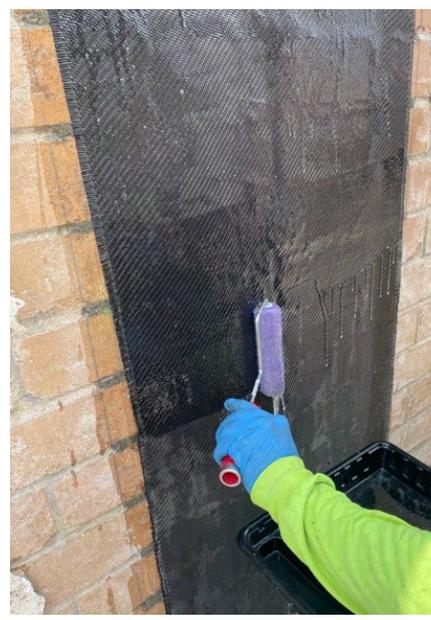
The low viscosity SRS-1000 Structural Epoxy Adhesive is designed to penetrate into the pores of the brick substrate to permanently bond and transfer the strength of the commercial grade carbon fiber fabric to the substrate.

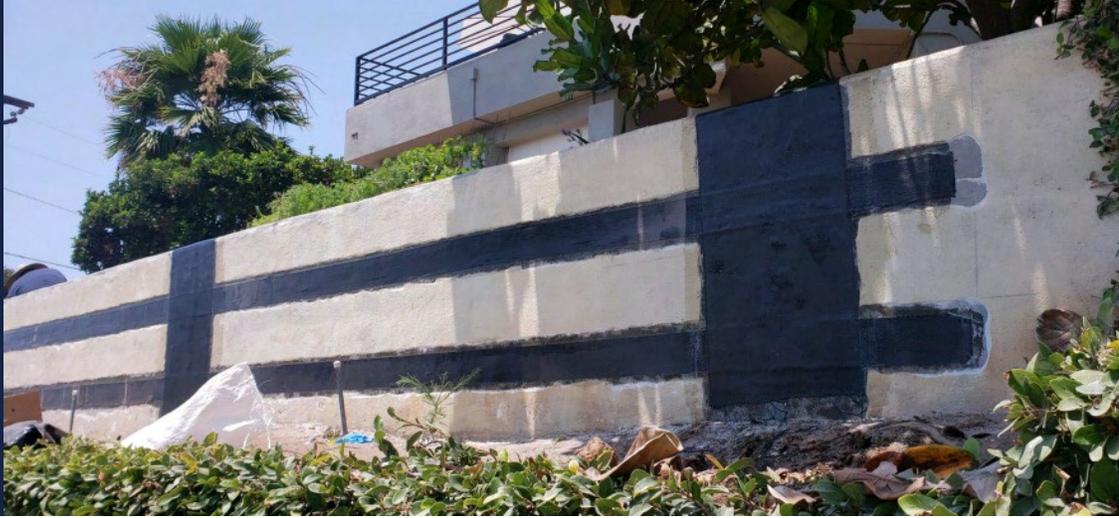
Due to the extremely high tensile strengths and very little elongation, the SRS-600 unidirectional carbon fiber is ideal to strengthen concrete structures such as columns, beams or walls. Providing design strengths over 196,000 PSI, this material delivers much greater reinforcement capabilities than steel, is non-corrosive, and at a fraction of the weight by comparison.

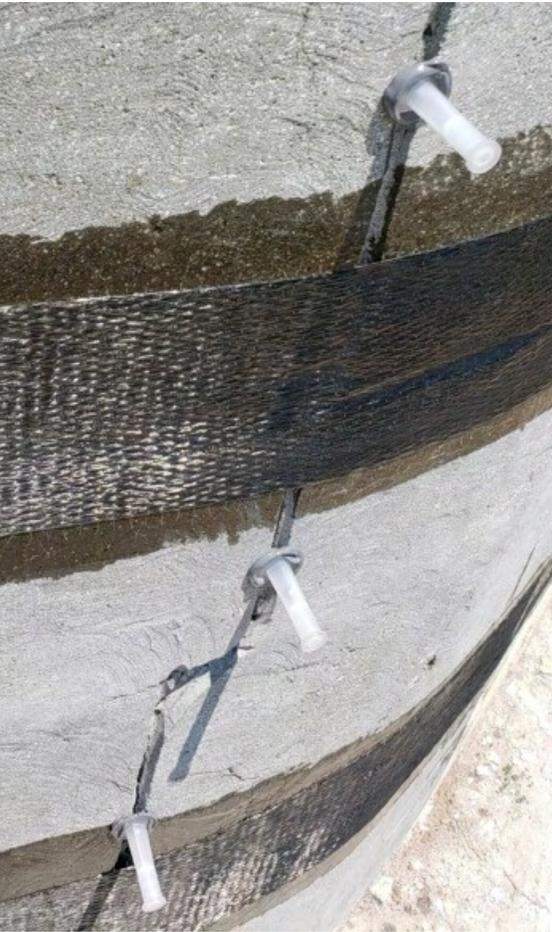
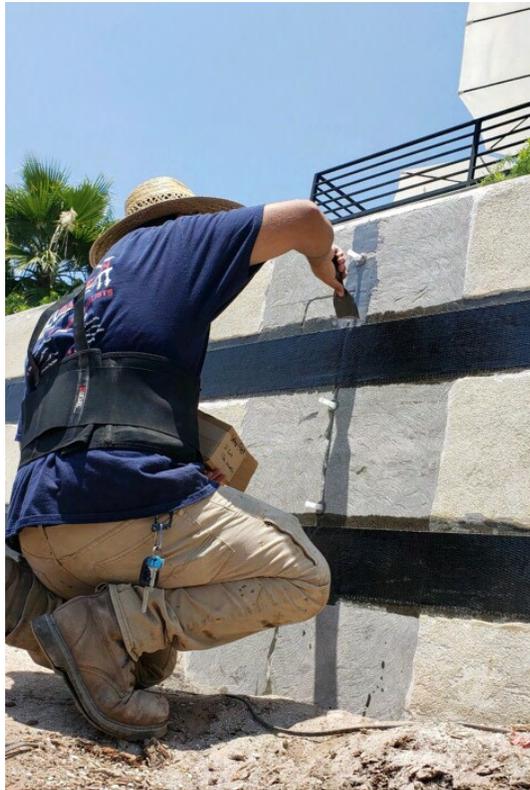
Injection ports were secured to both sides of the vertical cracks prior to them being injected with SRS-1000 Structural Epoxy Resin. The high strength non-compressible resin was used to fill the voids and bond both sides of the wall together at the crack locations.

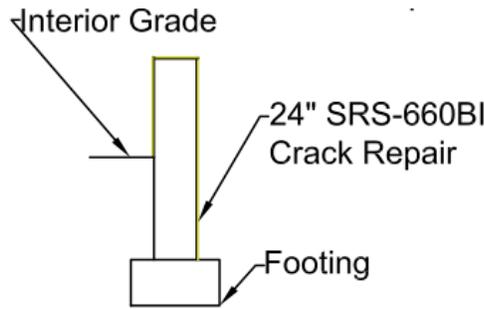
With a confinement strength of over 35,000lbs per sq/ft, the 24" SRS-660 Bidirectional carbon fiber extended up the outside face, across the top and down the inside face of the wall cracks.
