COMMERCIAL RETAINING WALL REPAIR & STRENGTHENING WITH CARBON FIBER AND TIEBACKS

NCSD SPRING MOUNTAIN ELEMENTARY SCHOOL
HAPPY VALLEY, OR, USA

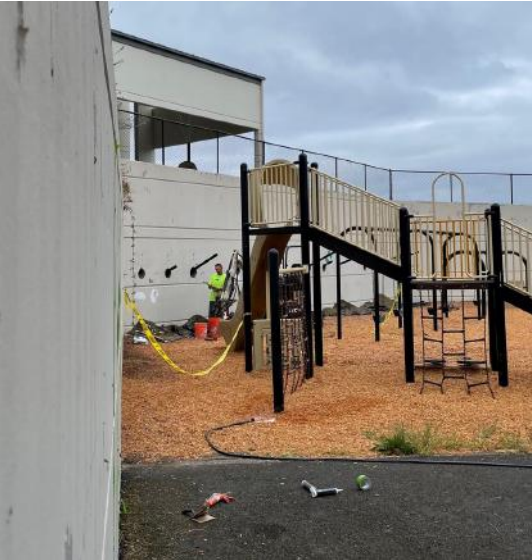
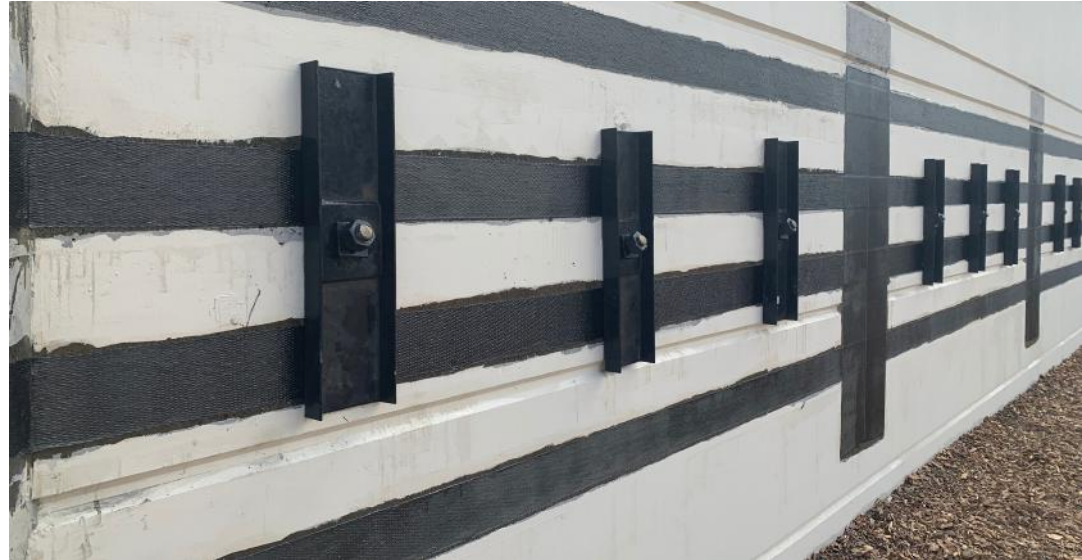
This retaining wall, adjacent to the covered play area and playground located at NCSD Spring Mountain Elementary School in Happy Valley, OR was constructed in approximately 2000. A horizontal outward bow of the wall was observed and additionally, cracking was observed on the high side of the wall between the asphalt paving and the back surface of the retaining wall. Vertical cracks were also present throughout the wall length.

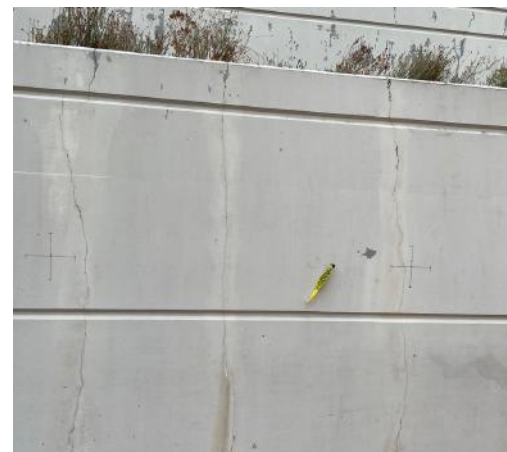
Based on the original construction drawings, the existing retaining wall was designed assuming the wall would be restrained at the top by a concrete slab. However, the asphalt paving that existed behind the wall would not allow for restraint of the wall. In addition, the placement of the vertical reinforcing steel shown in the original construction detail did not appear to be located correctly for the wall to act in a restrained condition. Without the rebar dowels into the slab, the wall was determined to be unstable under anticipated lateral earth pressures leading to the bow in the wall that was observed.

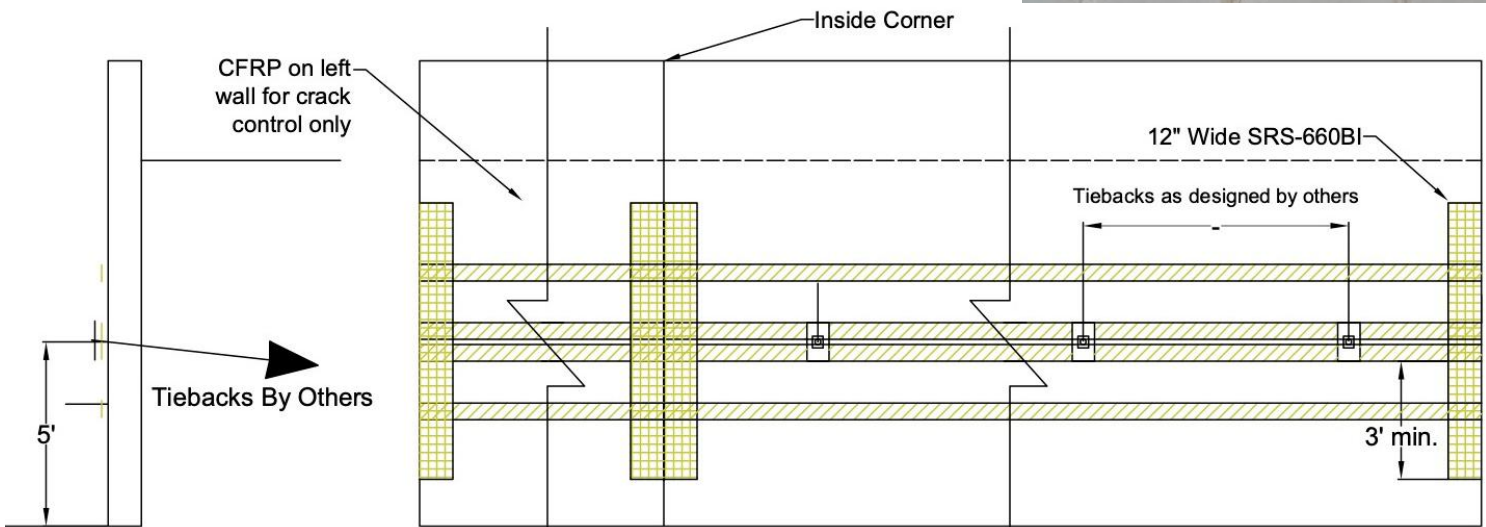
CARBON FIBER STRENGTHENING SYSTEMS

In order to verify the wall construction additional destructive and non-destructive testing was required. As an alternative to performing further testing to verify the construction of the existing wall, Miller Consulting Engineers, Inc determined reinforcing measures should be designed and implemented to stabilize the existing wall.

Local foundation repair contractor Ram Jack West reached out to Structural Reinforcement Solutions for a carbon fiber strengthening solution to be used in conjunction with wall tie backs.

In a collaborative effort from Oregon based NORTHWEST STRUCTURAL ENGINEERING GROUP LLC, Fortified Engineering Solutions and Uzman Engineering, SRS-600 unidirectional and SRS-660 bidirectional carbon fiber were specified to restore strength and stability to the playground wall.

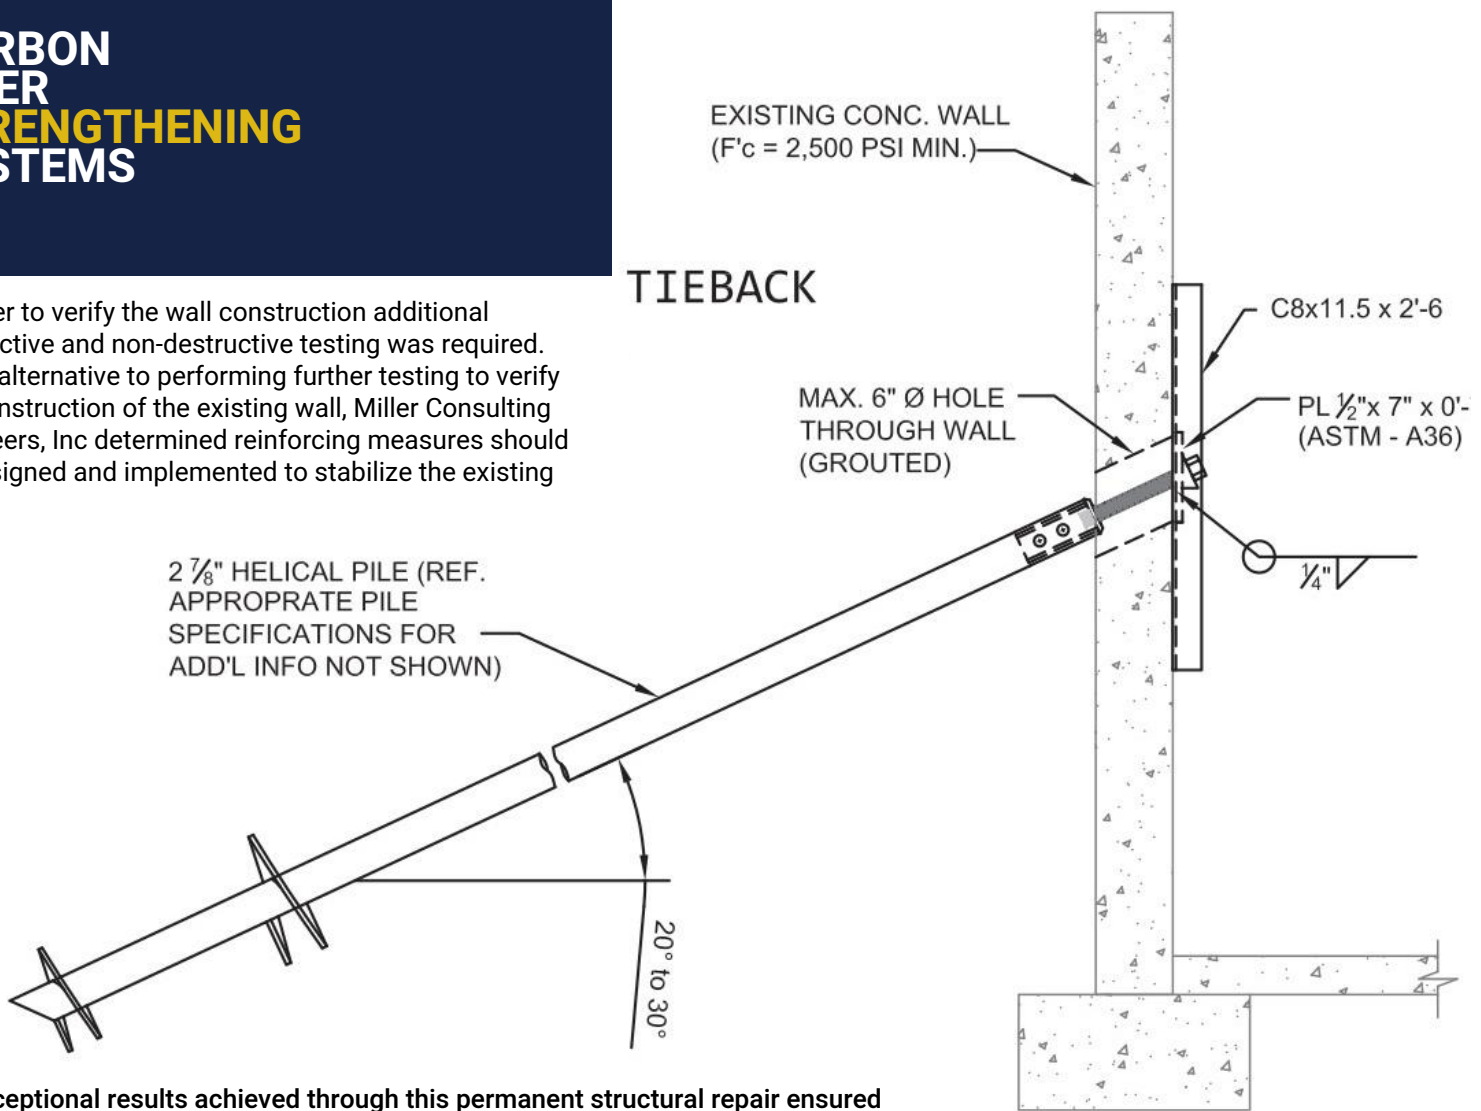
TIEBACK

The exceptional results achieved through this permanent structural repair ensured the safety of the students playground for generations to come.
