VEHICLE IMPACT CONCRETE COLUMN REINFORCEMENT WITH WITH CARBON FIBER

TULSA, OK, USA

CARBON FIBER STRENGTHENING SYSTEMS

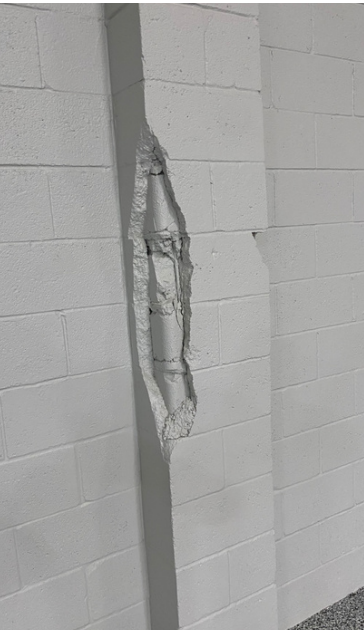
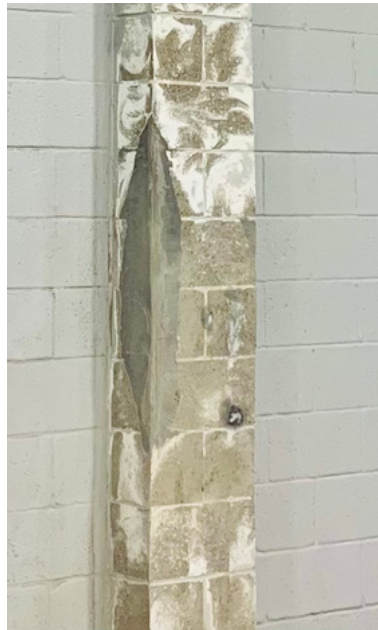
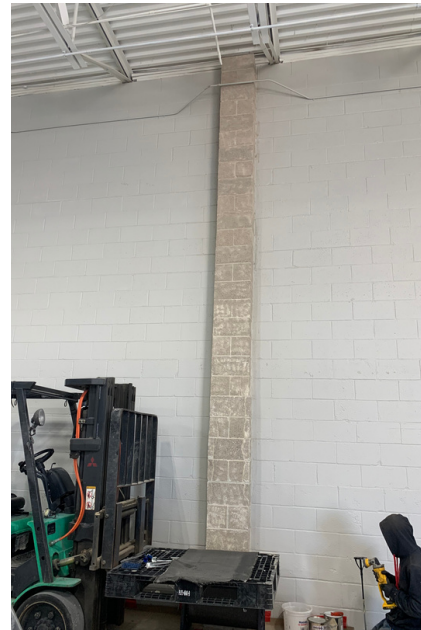
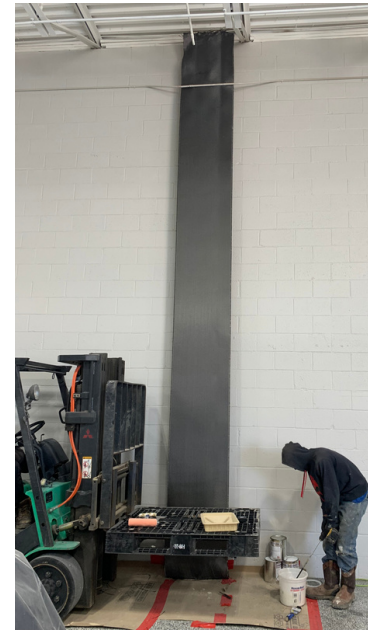
Following an inspection from Metro Structural Services in Tulsa, Oklahoma it was determined that several of the CMU support columns were compromised from forklift impacts and in need of reinforcement. Metro utilized SRS's 660 Bidirectional heavy weight commercial grade carbon fiber fabric to permanently strengthen the damaged concrete columns.

Once the the damaged areas of the concrete columns had been patched and all voids and section loss were filled, the surface of the CMU was prepared and Metro applied the 24" wide bidirectional carbon fiber over the columns.

The CFRP not only repairs and reinforces the columns but also provides strength over any necessary patches that were installed. The added strength over these patches will help to increase the effectiveness and lifetime of the repairs to permanently reinstate their structural capacity.
