CASE STUDY

COASTAL CONCRETE COLUMN REINFORCEMENT: A STEP-BY-STEP GUIDE

OCEANSIDE DRIVE, SCITUATE, MA

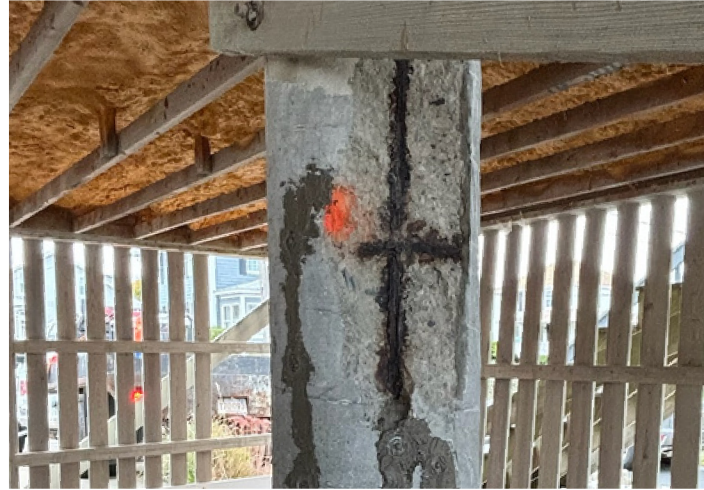
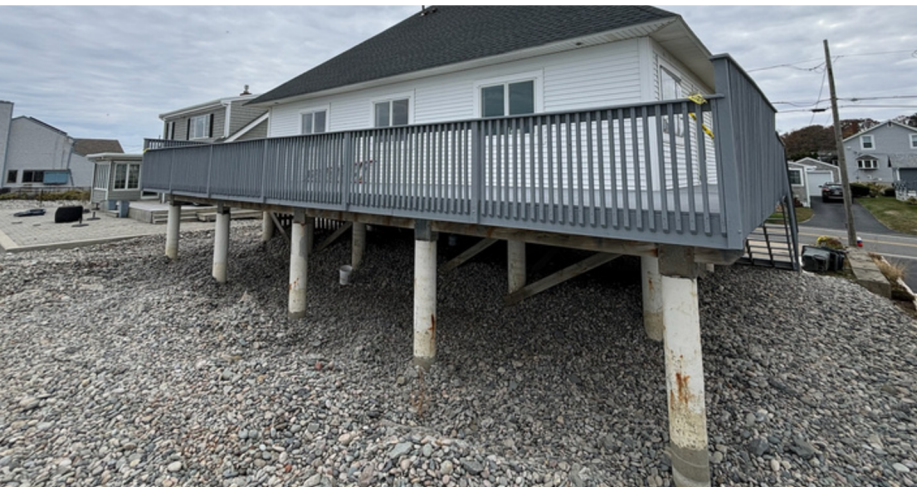
The coastal environment along Oceanside Drive in Scituate, MA, posed unique challenges for the structural stability of nine concrete columns, which had suffered severe deterioration from the relentless Atlantic saltwater exposure and harsh coastal weather.

This coastal concrete column reinforcement project serves as a step-by-step case study, showcasing how Ram Jack North East, awarded the project, collaborated with Structural Reinforcement Solutions to restore the columns' strength and durability.

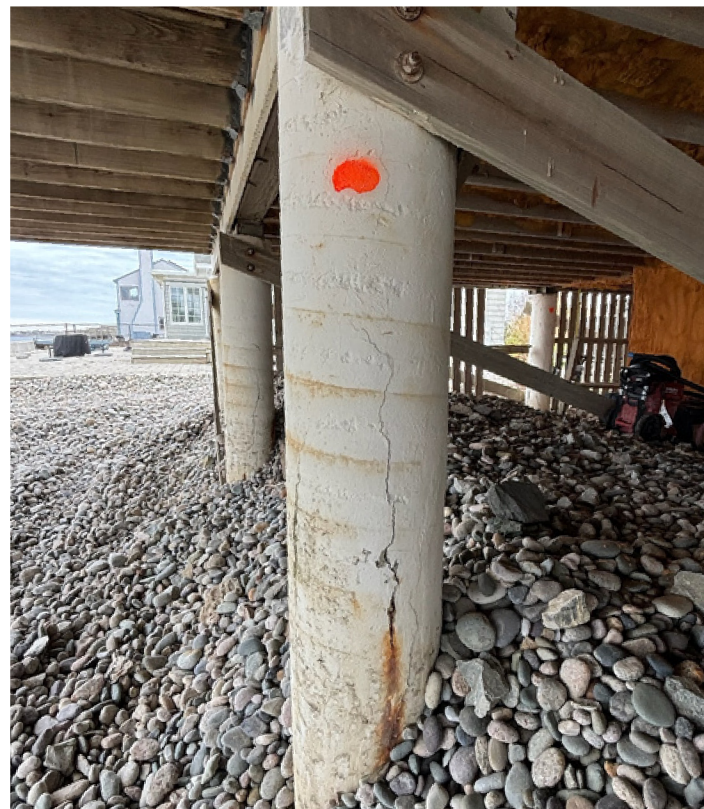
**Initial Surface Preparation and Treatment**

The project began with thorough surface preparation. Paint, contaminants, and loose material were carefully removed to open the concrete's pores, creating an optimal surface profile. This essential step ensured proper adhesion for the upcoming repair treatments and reinforcement products.

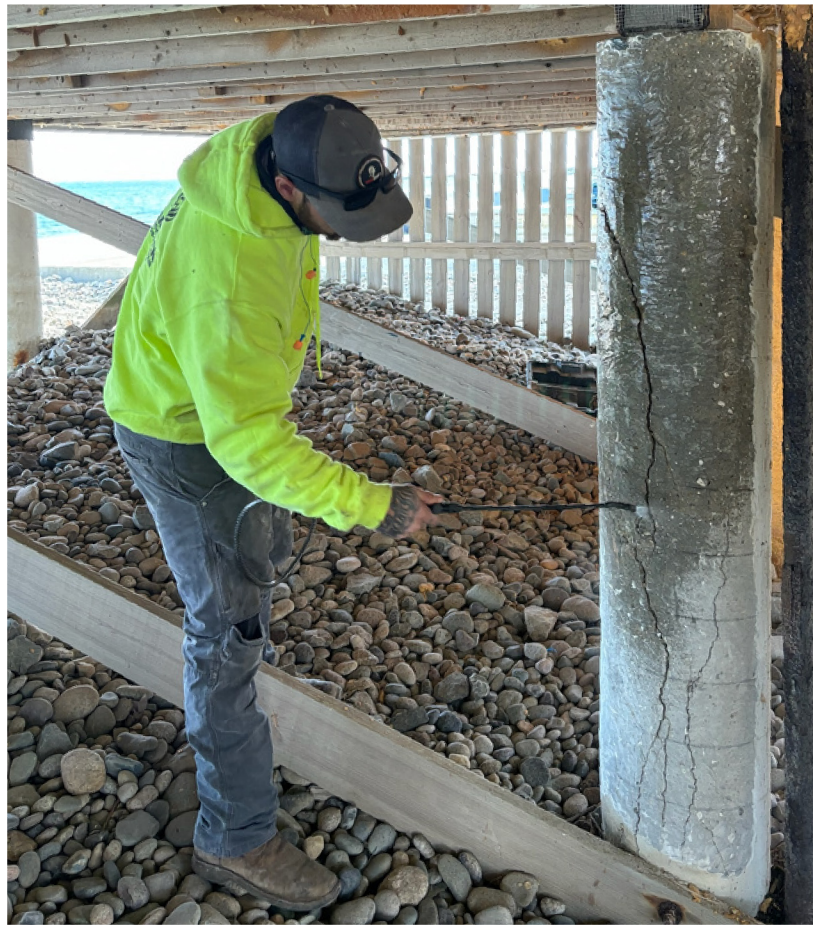
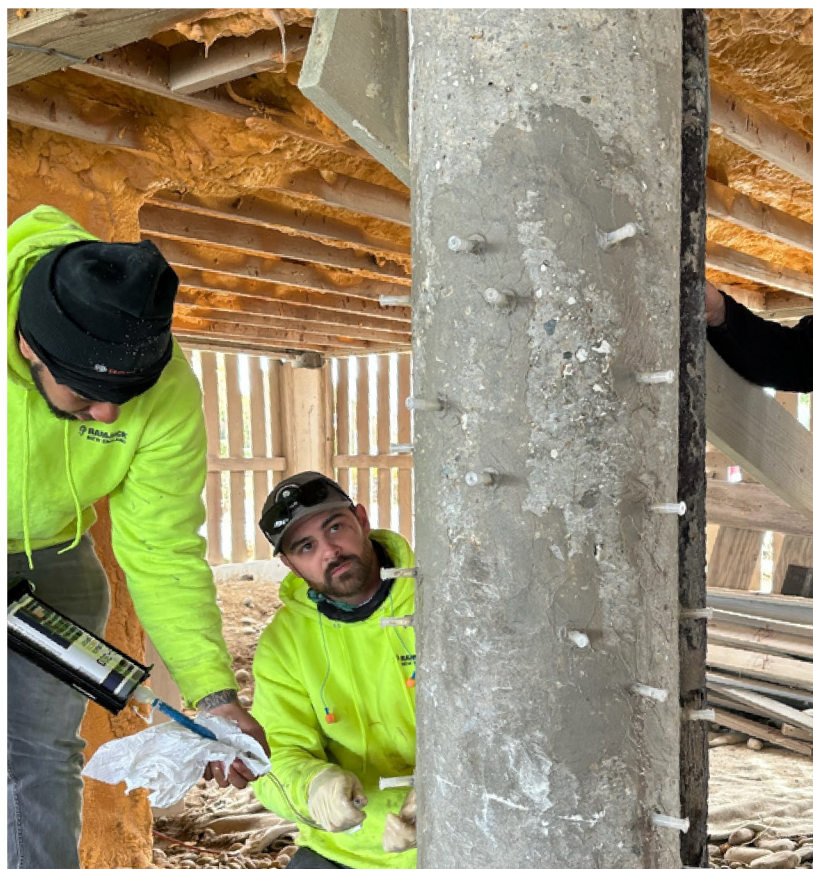
Structural Crack Repair with SRS-3000 Epoxy and SRS-2100 Rapid Cure Concrete Repair Paste

For existing cracks in the concrete, SRS-3000 Low Viscosity Epoxy Injection Resin was applied to restore structural integrity. This high-strength epoxy penetrated deeply into the cracks, sealing them securely and providing a reliable repair.

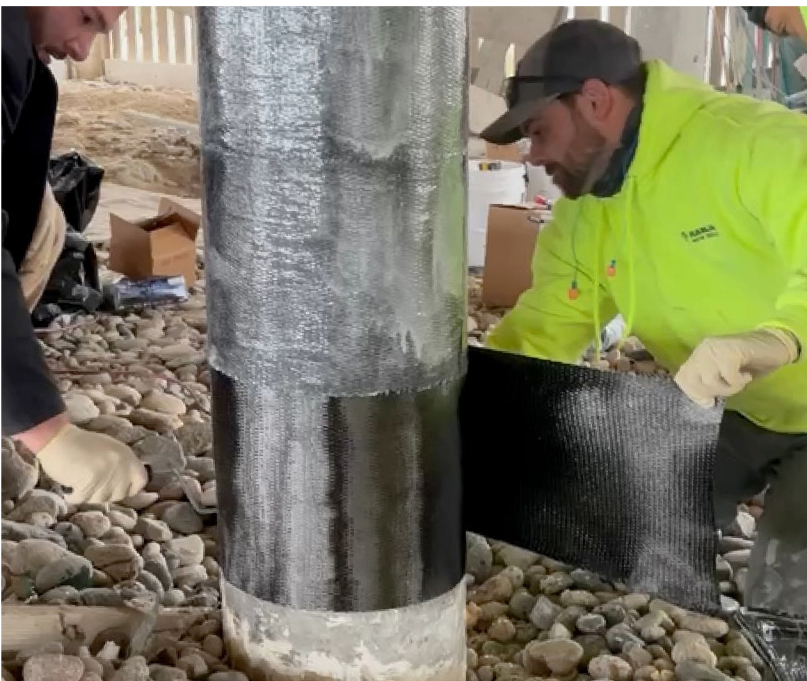
Reinforcement with SRS-1000 Structural Epoxy Adhesive and SRS-600UNI Carbon Fiber Fabric

Finally, the columns were reinforced with the combined system of SRS-1000 Structural Epoxy Adhesive and SRS-600UNI Carbon Fiber Fabric. The SRS-1000 epoxy provided a strong bond, ensuring the carbon fiber adhered securely to the concrete.

SRS-600UNI, with its high strength-to-weight ratio, conformed seamlessly to the columns' shape, increasing load capacity, shear strength, and overall stability. This cohesive system minimized movement and provided a long-lasting, non-corrosive reinforcement solution tailored to withstand the coastal elements.

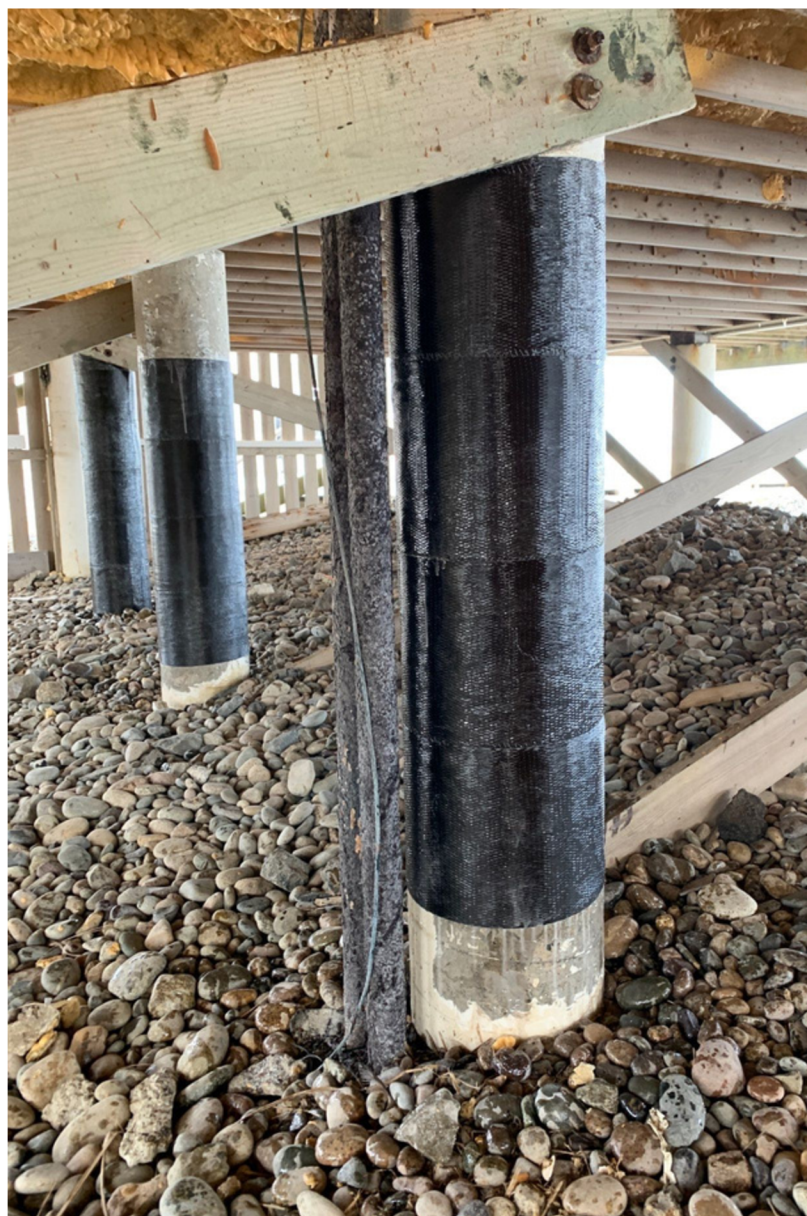
Results and Conclusion

Through the combined expertise of SRS and Ram Jack North East, each concrete column was restored to meet the demands of its coastal environment. The tailored use of SRS products not only repaired the concrete columns but also fortified them against future deterioration, delivering a durable and resilient solution.
