# CARBON FIBER BOWED WALL STABILIZATION

TOMS RIVER, NEW JERSEY

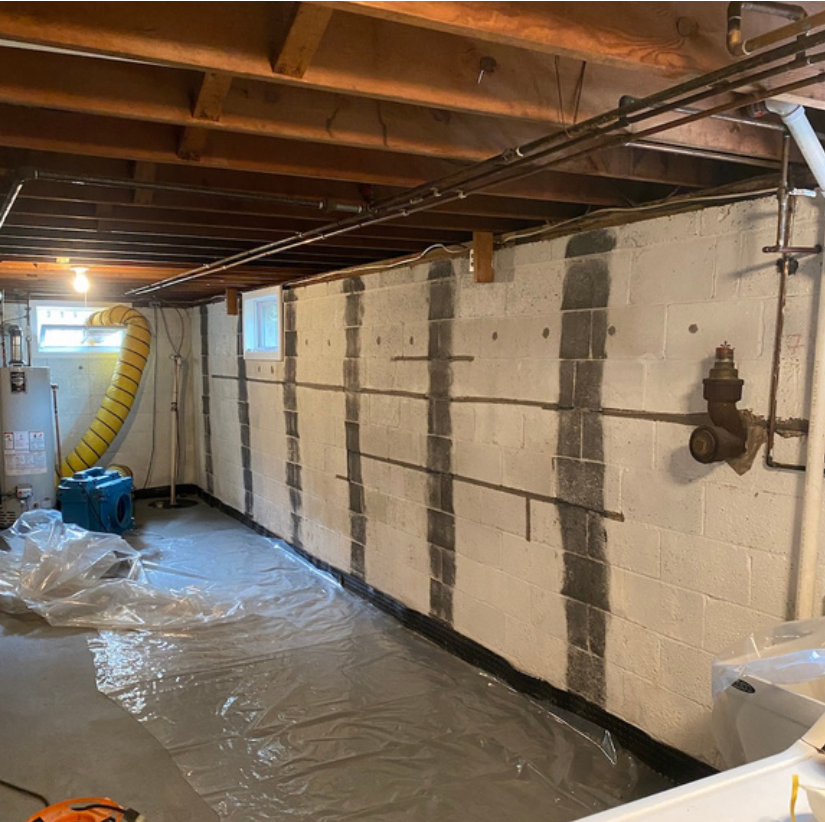
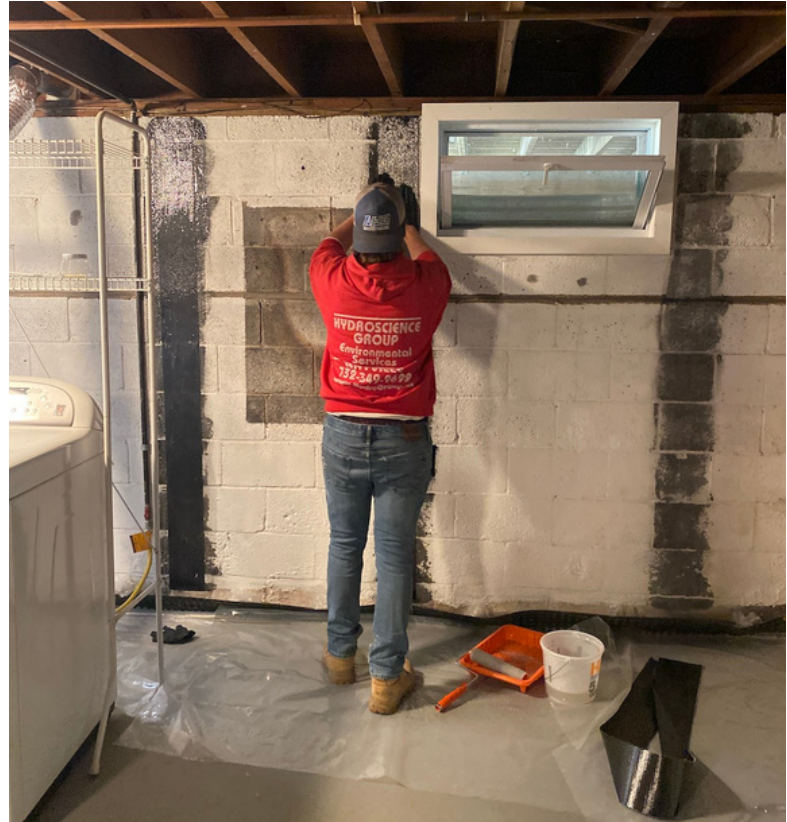
When installing a carbon fiber bowed wall system, the prep work of the wall is one of the most important components. If the wall is not prepared properly, the straps will not be engaged to their full capacity and failures become more likely.

Grinding and preparing the wall per the manufactures recommendations is not the only item that has to be addressed during the wall prep phase. While grinding the wall promotes higher epoxy bond strengths, repairing the damaged mortar joints is just as important.

The tensile strength of the carbon fiber will resist any further inward movement of the wall, but in order to lock the wall in place, the mortar joints also need to be repaired as well. The best way to do this is the knock out the cracked mortar and completely re-tuck these joints.

As you can see in the pictures above, Hydrosience thoroughly repaired the mortar joints and prepped the walls for the carbon fiber installation. The meticulous prep work and installation along with the industry's most complete carbon fiber bowed wall system provided peace of mind for the buyer of the property allowing the pending real estate transaction to go through. Hydrosience not only provided the new home owner with a lasting repair but one that will be warranted for the life of the structure.
