CARBON FIBER HOLDING TANK CRACK REINFORCEMENT

SOUTHERN CALIFORNIA, USA

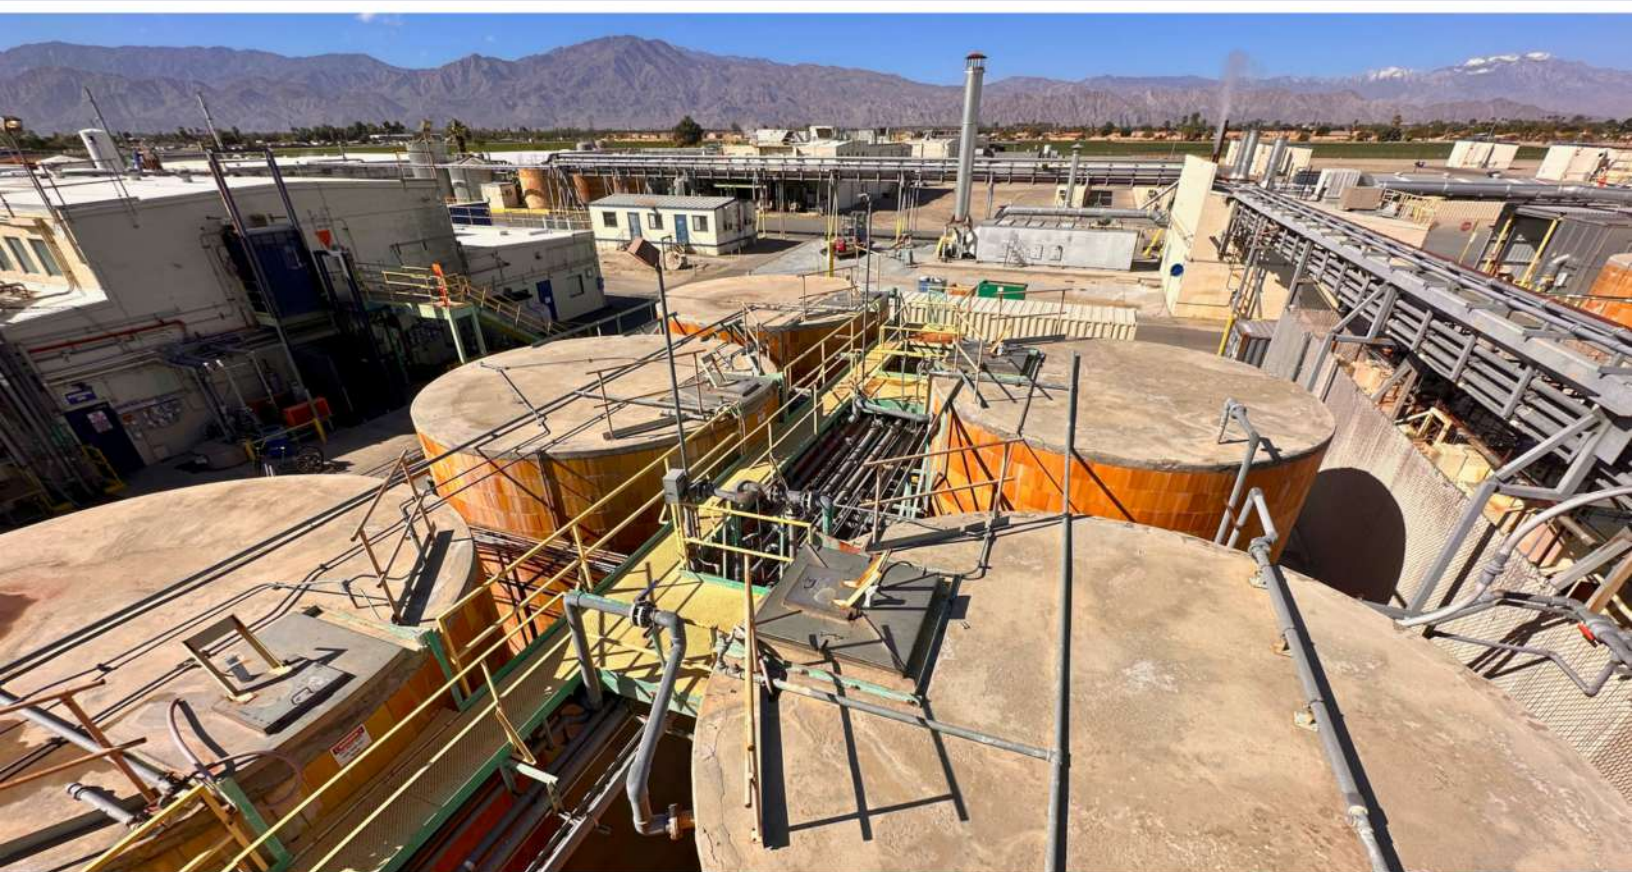
The use of CFRP for crack repair is a great solution that not only confines the cracked concrete but when applied properly, strengthens the structural elements as well. This strengthening may be to handle increased loads, restore damage where rebar section loss is present, or even where elements have failed. Crack confinement with CFRP is invaluable as it not only strengthens areas of broken concrete, but waterproofs these repairs as well.

In this case, Dalinghaus Construction was working with the owners of a large chemical processing plant in Southern California in order to put together a plan for concrete repairs on a few tanks that the owner had concerns with. The main item of concern was the concrete lids on the holding tanks. Representatives from Dalinghaus and SRS walked the site with the owners representative in order to understand the items of concern.

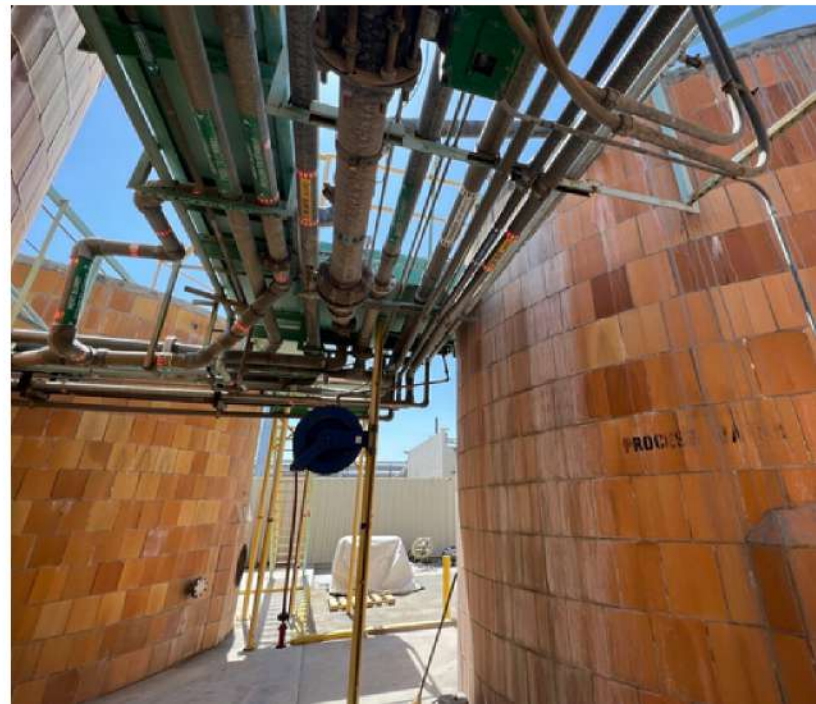
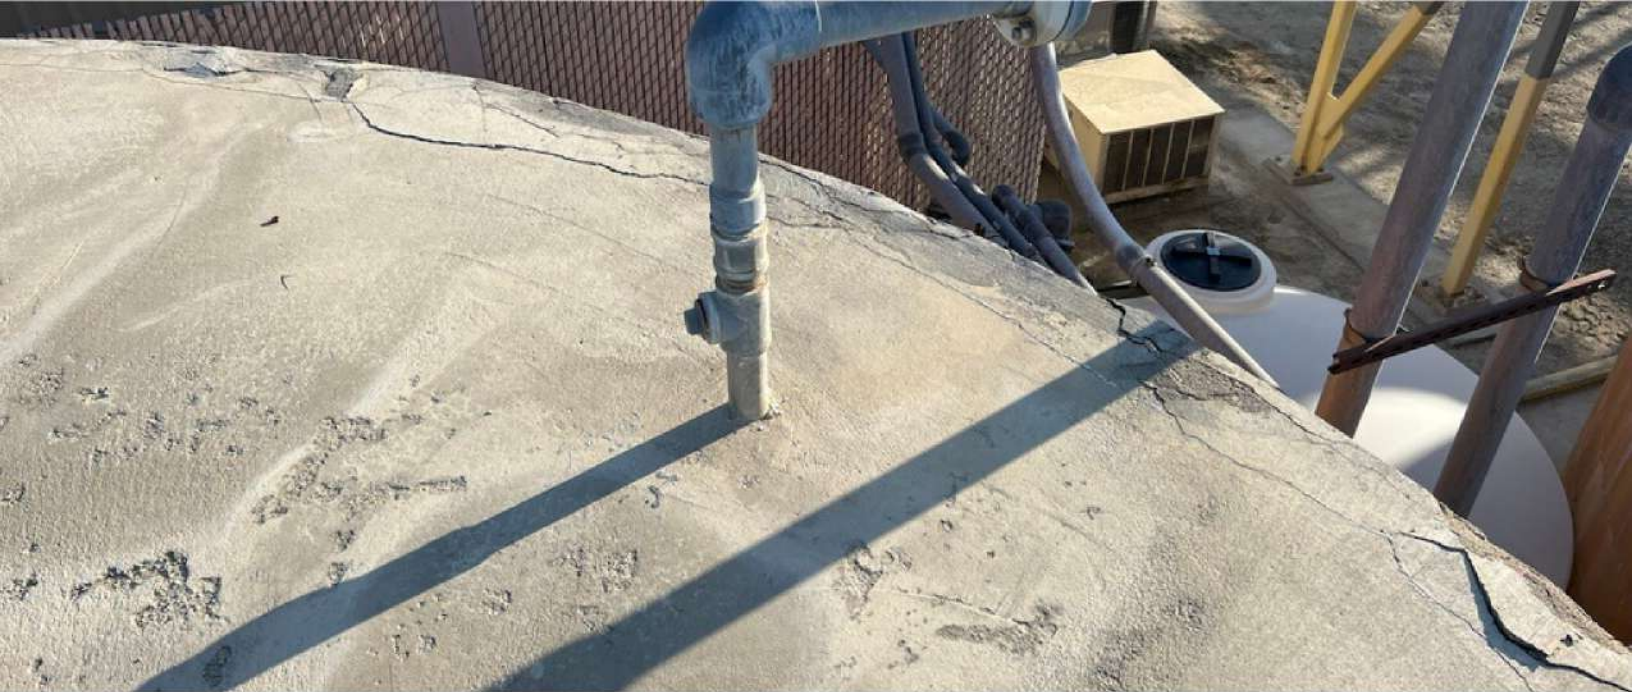
There was a fair amount of cracking on the outer perimeter of the lids as well as around the opening to the tanks. Upon completing the inspection on the tanks, a plan was put together to repair the concrete and confine the entire outside edge of the tanks as well as the tank openings with SRS-660BI.
