# PROTECTING CRITICAL INFRASTRUCTURE: COLUMN REPAIR FOR TELECOM TOWERS

MARATHON, FL

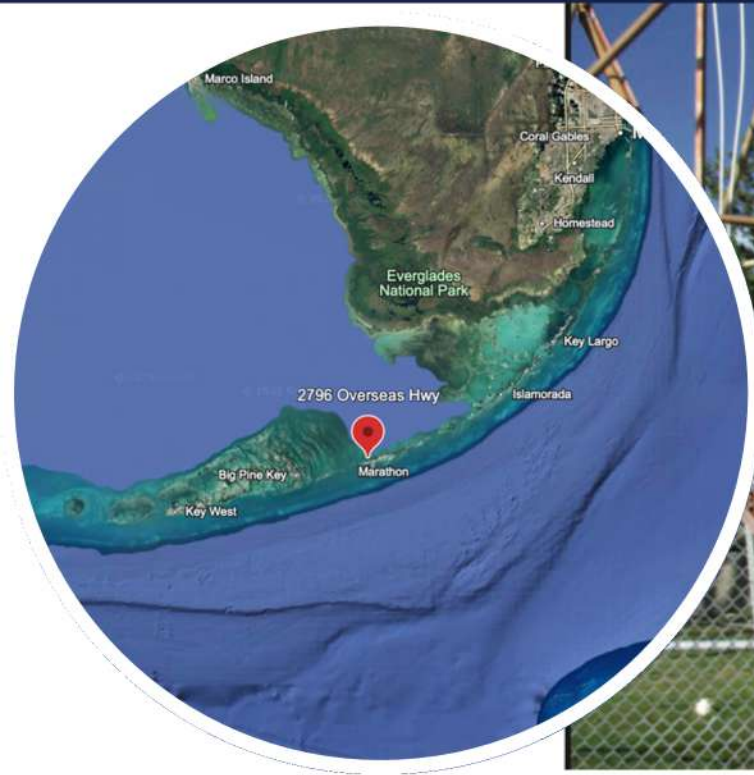
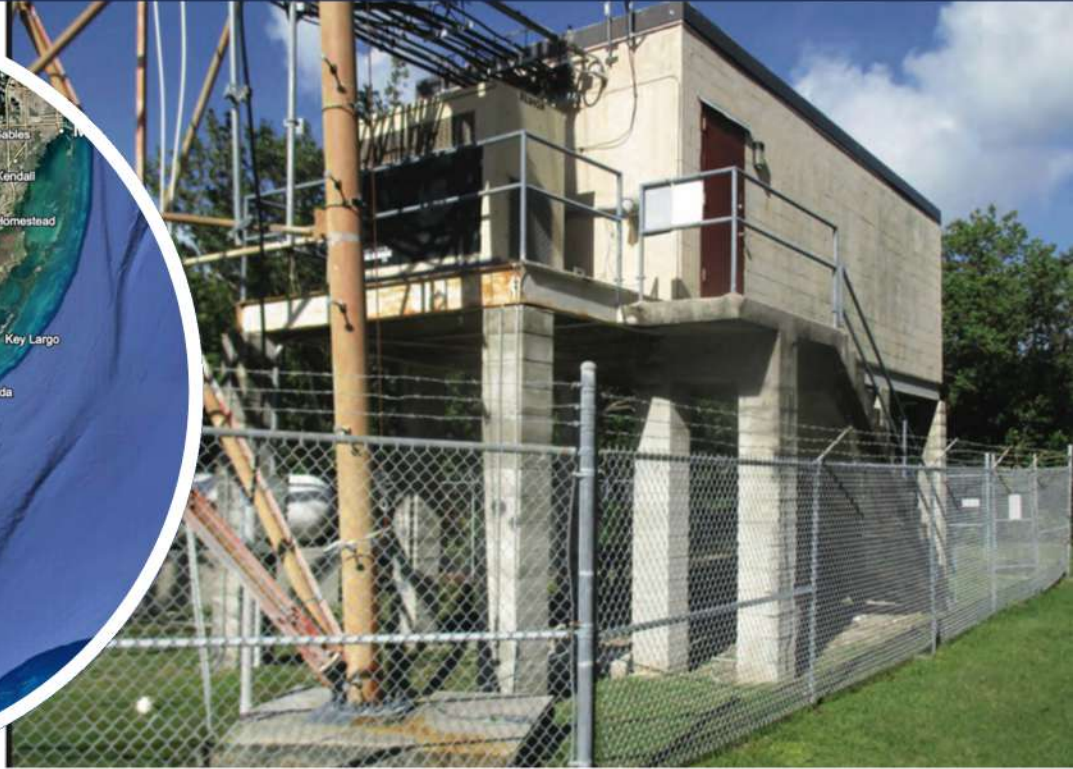
An emergency telecommunications tower in the City of Marathon, Florida, required structural reinforcement of its concrete masonry support columns, which exhibited signs of deterioration including surface cracking and minor spalling. Given the tower's essential role in public communications and its exposure to a high-humidity coastal environment, a non-invasive, surface-applied strengthening system was specified. The repair utilized a fiber-reinforced polymer (FRP) solution consisting of bidirectional carbon fiber fabric and high-strength epoxy—providing structural confinement, enhanced load resistance, and long-term durability in corrosive marine conditions.

Structural Reinforcement Solutions' SRS-660BI Carbon Fiber System was specified to provide a high-performance, surface-applied strengthening method for deteriorating concrete columns. The bidirectional fiber-reinforced polymer (FRP) fabric was installed using SRS-1000, a high-strength epoxy engineered for secure bond performance and long-term durability. Together, these components formed a fully bonded composite wrap that provided structural confinement and enhanced resistance to environmental exposure—delivered without the need for demolition or disruption to service.

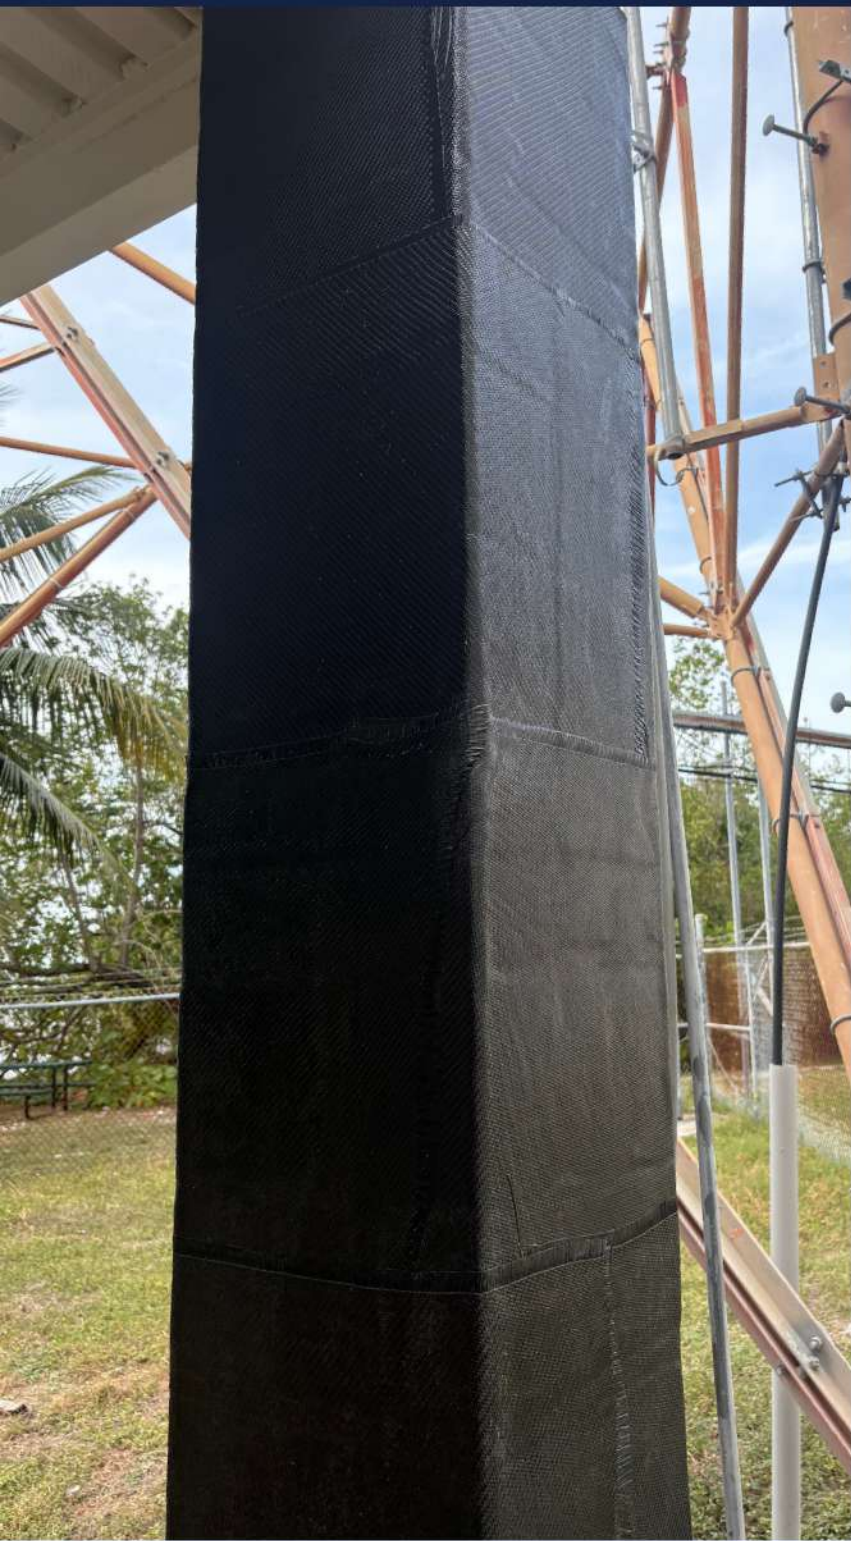
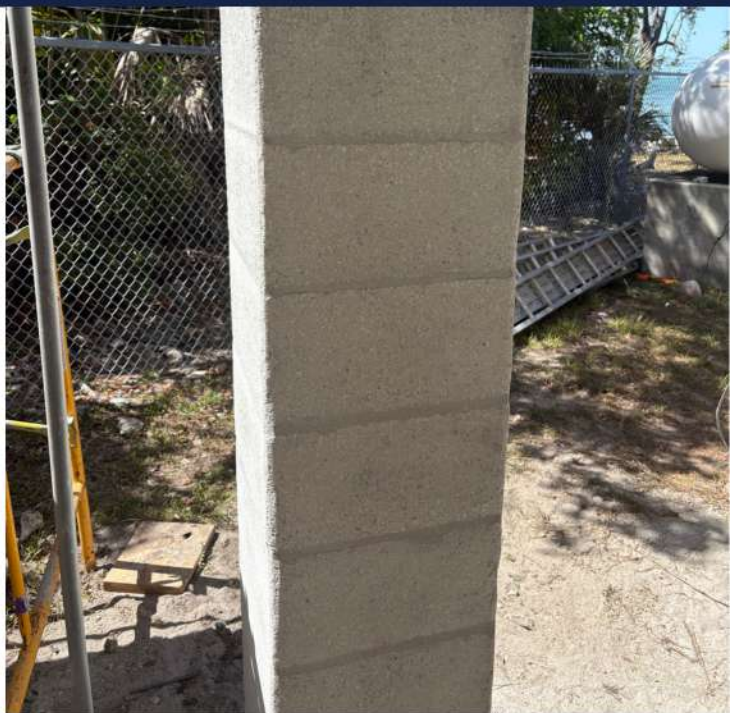
- SRS-660BI Bidirectional Carbon Fiber Fabric – Applied to wrap and structurally confine the concrete columns, enhancing strength and durability
- SRS-1000 Structural Epoxy Adhesive – Used to saturate and bond the carbon fiber directly to the prepared concrete surface

**\*\*** In cases where concrete exhibits more advanced deterioration—such as significant voids, surface degradation, or indications of embedded steel corrosion—supplemental products including SRS-2100 Structural Repair Paste, SRS-4000 Concrete Guard, and SRS-4100 Steel Guard may be incorporated to improve substrate integrity, enhance bond conditions, and mitigate long-term durability risks.

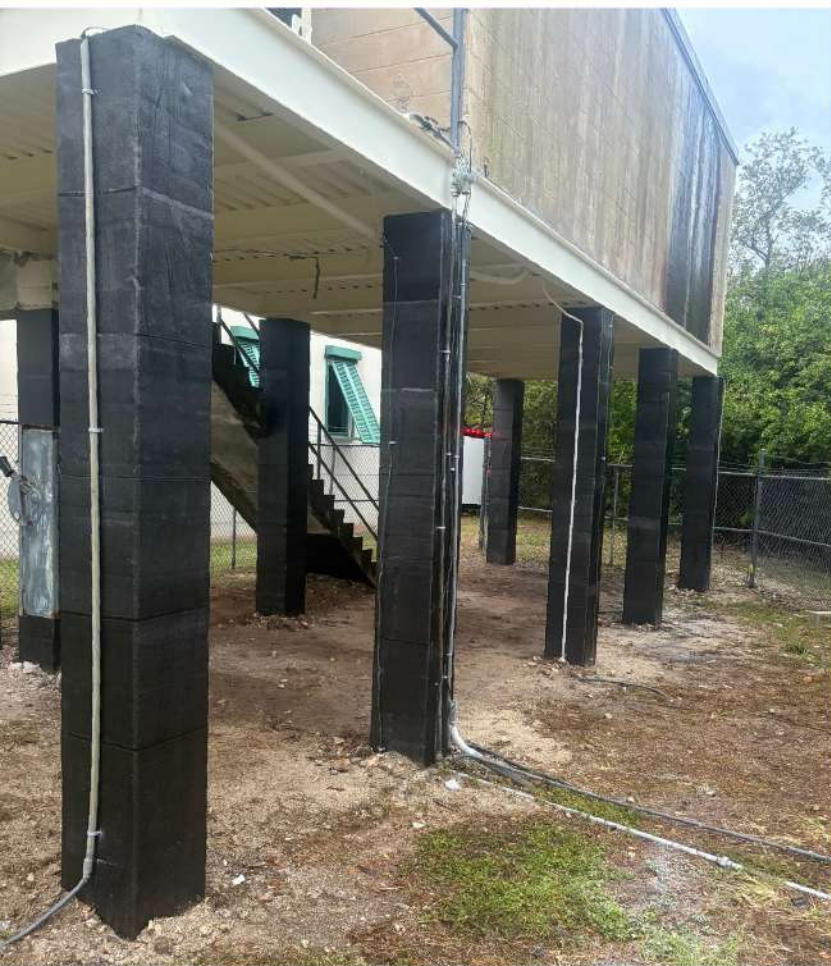
The repair began with surface preparation to remove loose or deteriorated concrete and ensure a clean, sound substrate. Once prepped, SRS-660BI Bidirectional Carbon Fiber Fabric was applied using SRS-1000 Structural Epoxy Adhesive, which was used to saturate the fabric and bond it securely to the column surface. This process created a high-strength composite wrap that provided structural confinement and long-term reinforcement.
