CARBON FIBER BLOCK WALL REINFORCEMENT

SOUTHERN CALIFORNIA, USA

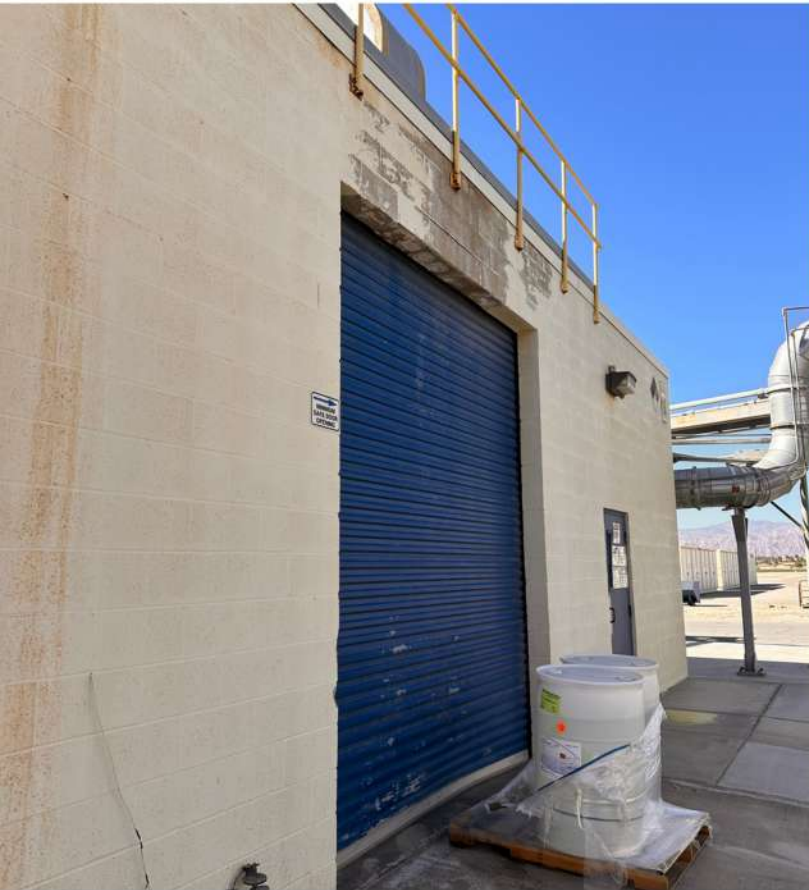
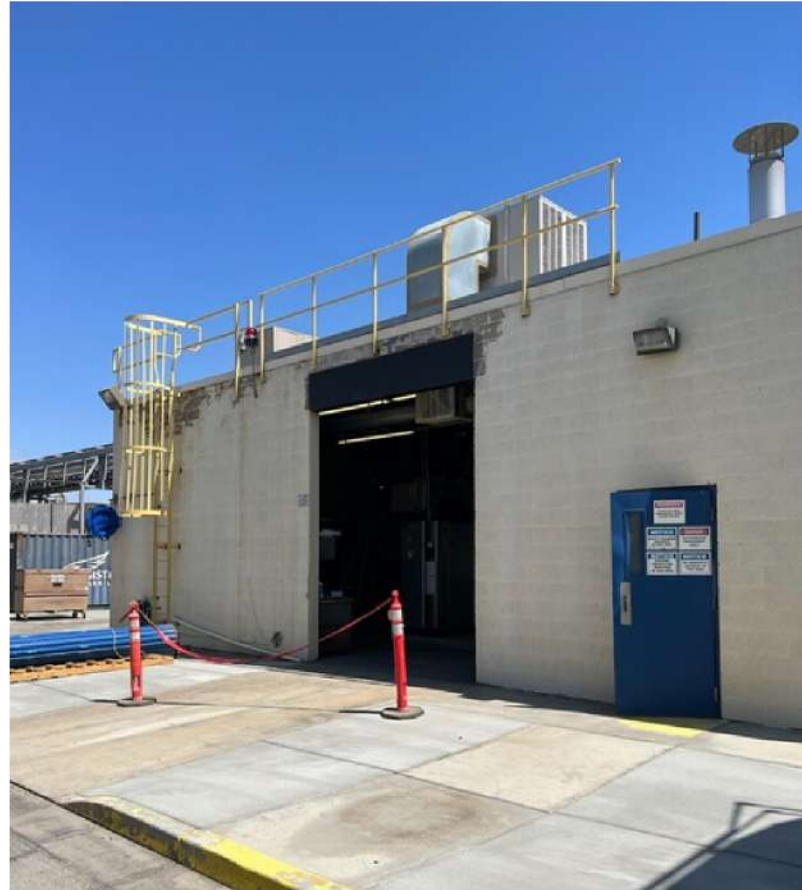
An industrial chemical plant faced structural challenges in its central boiler building. The CMU block building exhibited cracks, deteriorated areas, and opened mortar joints, leading to concerns about the overall integrity of the structure. Cracking around an overhead door opening was observed on the site walk and SRS put together a plan to reinforce and repair these areas.

To address these issues and reinforce the building, a comprehensive carbon fiber crack repair solution was implemented. SRS-600UNI was utilized to provide "U" wraps as well as flexural strengthening to the section of the CMU wall above the overhead door opening. Other areas of cracking on the CMU building were confined with the SRS-660BI.

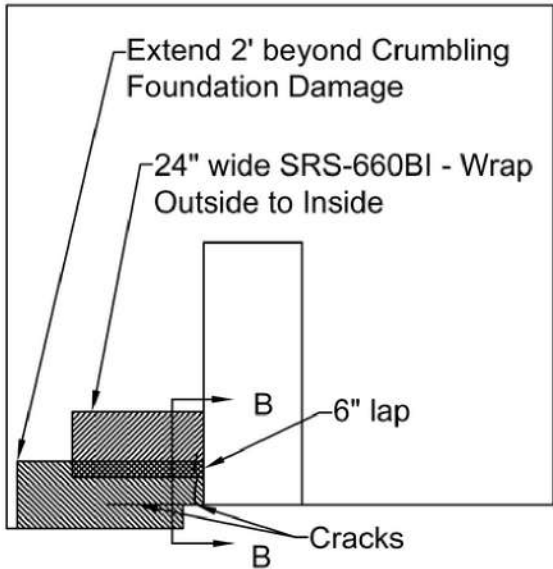
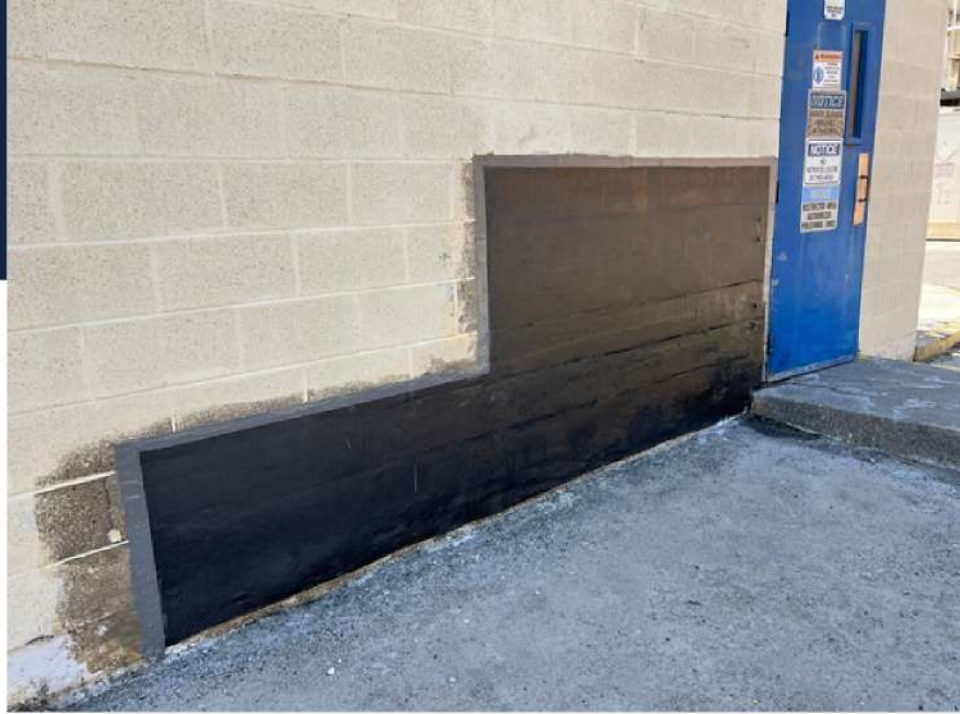
Before the carbon fiber reinforcement installation, all cracks, deteriorated areas, and opened mortar joints were carefully filled and patched to create a stable surface for the repair.

A layer of 6" wide SRS-600UNI was installed on the underside of the opening for flexural strengthening. Full confinement with "U" wraps were also provided to strengthen and tie the lintel into the wall above.

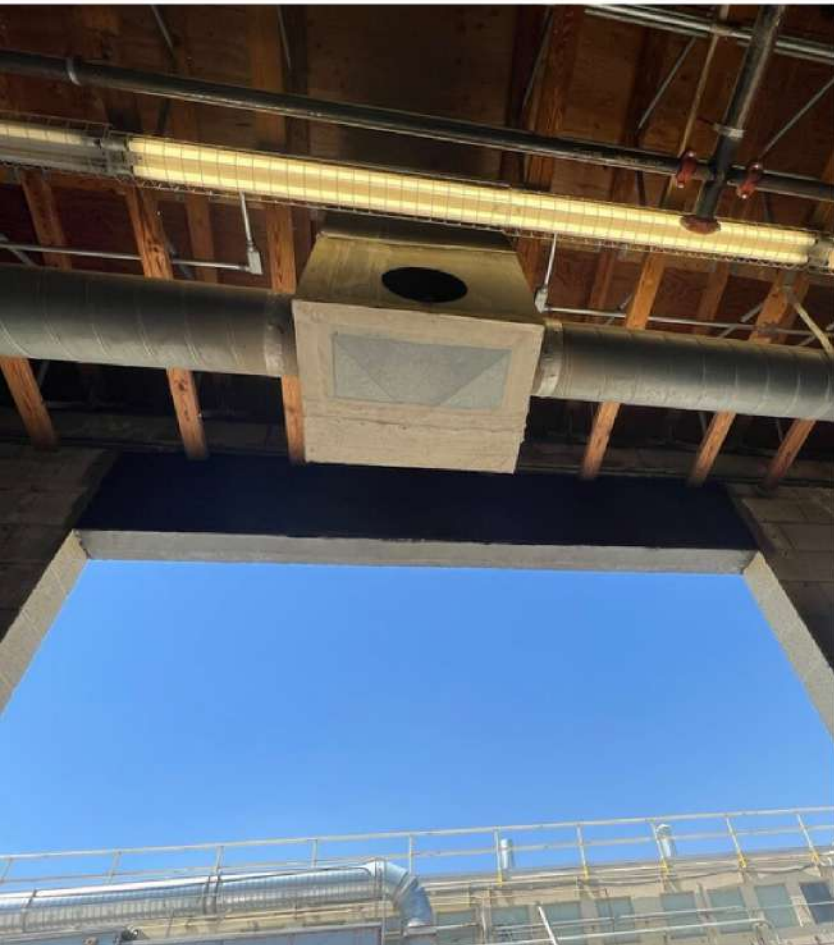
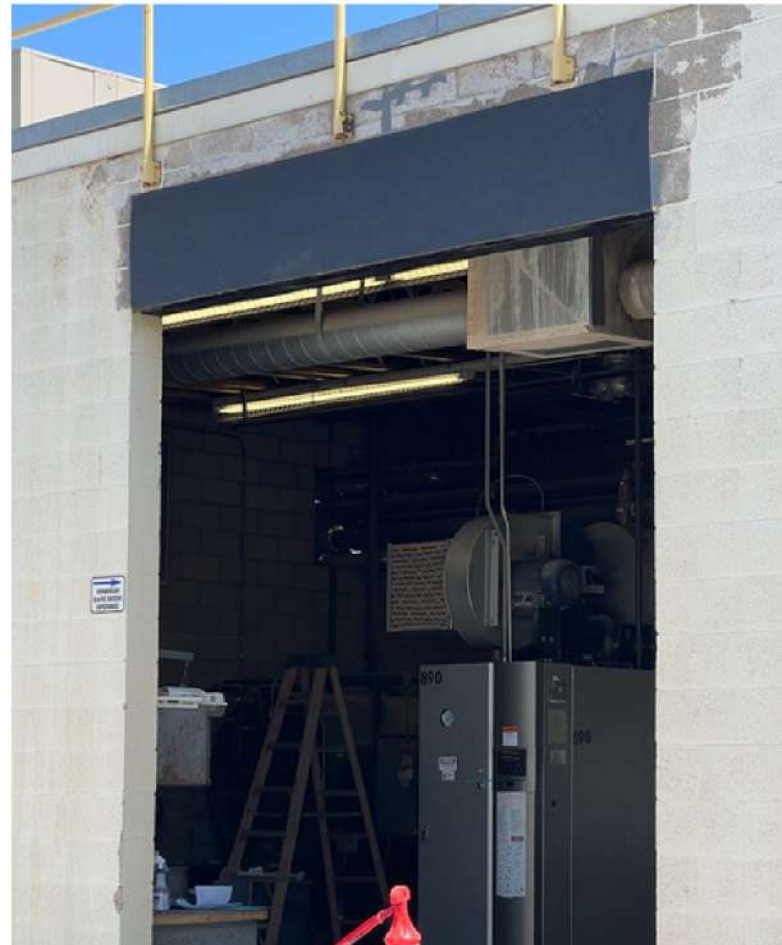
Once all of the concrete repairs were complete, CFRP was installed, and the appropriate protective coatings were applied, the facilities maintenance group no longer had to be concerned with these prior issues.
