# STRUCTURAL REINFORCEMENT SOLUTIONS

CONCRETE SLAB EMBED PULLOUT STRENGTHENING WITH CARBON FIBER

DENVER, CO, USA

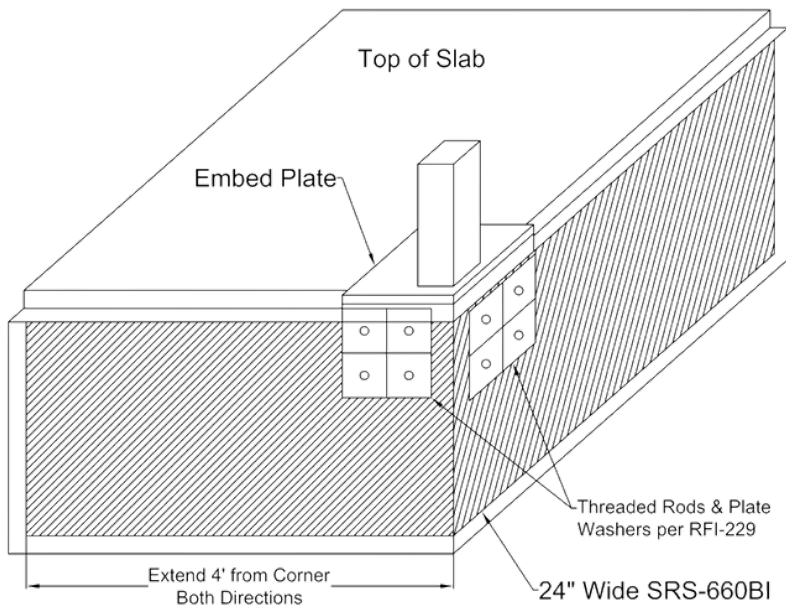
RFI-229

The contractor on a high rise condo building in Denver Colorado reached out to Structural Reinforcement Solutions after cracking was discovered around the embeds on the edge of a 27" thick structural, post-tensioned slab.

The concern was raised when some cracking around the embeds was noticed. It was thought that this could have been attributed to the heat generated when welding the steel columns onto the plates but upon further investigation, they were unable to verify that there was any rebar directly under the embedded plates to provide confinement for nelson studs.

These embedded rods proved difficult to drill and miss the reinforcing steel further back in the slab. The amount of cracking also increased as these anchors were drilled. Structural Reinforcement Solutions worked with the contractor and their engineers to come up with a solution to confine these areas and provide crack control.

Engineers on the project came up with a solution to drill and grout in a pattern of 4 each 2 – 7/8" threaded rods on each face and use plate washers on the surface to provide the necessary confinement.

4 ROWS OF 2- 7/8"Ø ALL-THREAD (F1554 GR55) W/ NUT & PL5X5X1/2 WASHERS ~DRILL & EPOXY (32" EMBED)

The anchors were still going to be needed but the SRS-660BI was to be installed to confine the areas and then once cured, the anchors could be drilled without worry of further cracking.

This also provided some factor of safety in case rebar was hit and a the holes had to be re-drilled. Once cured, a diamond tipped hole saw can be used to create a clean cut in the CFRP to facilitate the anchor installation.
