CASE STUDY

## CARBON FIBER BRICK COLUMN STRENGTHENING

OWENS-ILLINOIS GLASS FACTORY, ZANESVILLE OHIO

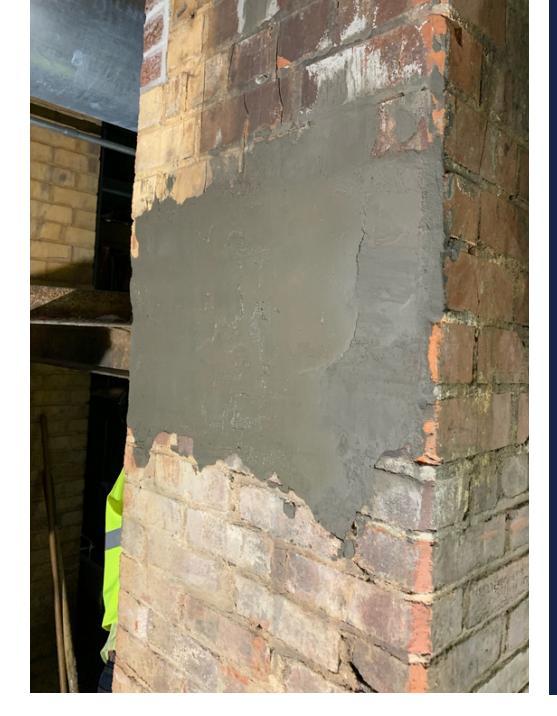
Owens-Illinois reached out SRS for an innovative solution to repair a cracked brick support column inside their historical glass making factory in Zanesville, Ohio. The columns support a furnace that holds more than 300 tons of molten glass when operating at full capacity. In the true fashion of their founder, they recognized carbon fiber's innovative potential to strengthen brick columns.

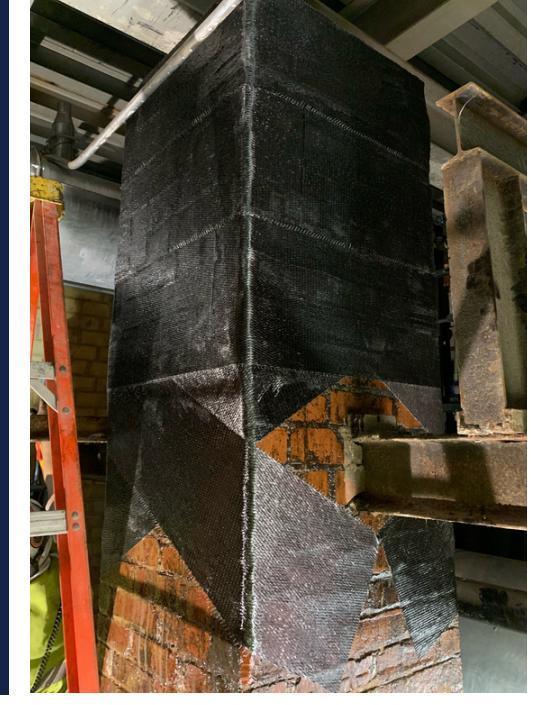
In order to provide a clean and effective installation, after the surface of the brick was prepped for the CFRP installation, any voids or uneven areas had to be filled and leveled out with a repair mortar.

After meeting with the Engineers from Owens-Illinois to understand the requirements of the column, SRS provided a repair plan that included the full encapsulation of the column using the SRS-600 Unidirectional carbon fiber.

The bond strength of confining repairs is not critical to the system's performance since it is fully wrapped. The wraps were lapped appropriately to achieve a bond strength equal to or greater than the tensile strength of the material essentially creating a continuous wrap.
